**Town of New Hartford - 175k GST  
Water Storage Tank Inspection**

**CorrTech Report No. 14845-FOR-01-1**

**1/26/2021**

### **Tank 2 174,000 Gallon Steel GST**

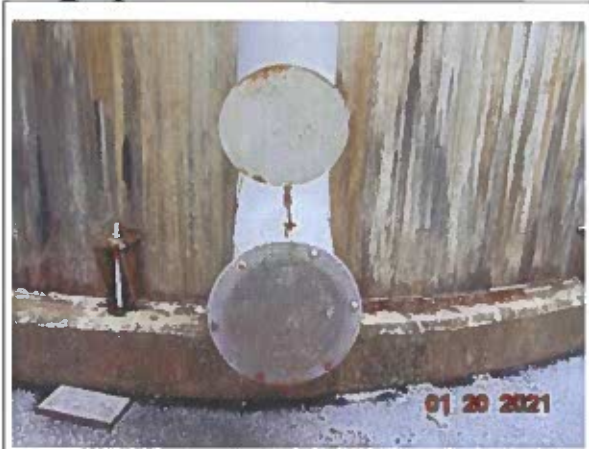
#4 Overflow with flapper valve and intact screen

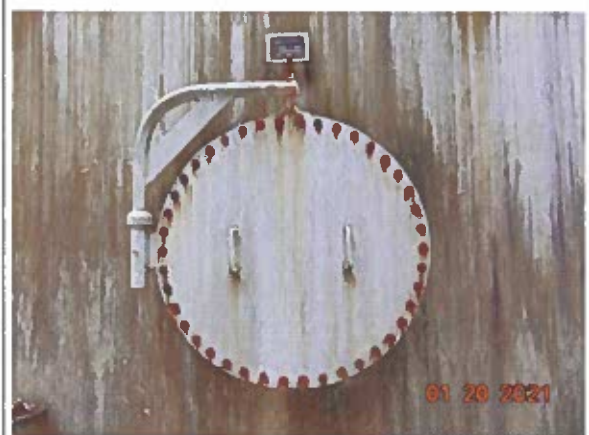
The tank has two shell manholes. All bolts are engaged on both and no signs of any leakage were identified.

#5 Shell manhole

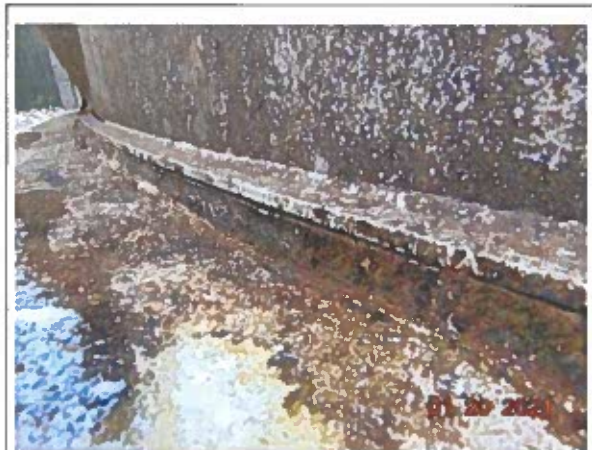
The tank foundation was free from any cracking or spalling. The caulking under the chime plate was covered in biological growth and bio-staining but was intact.

#10 Typical view of chime grouting

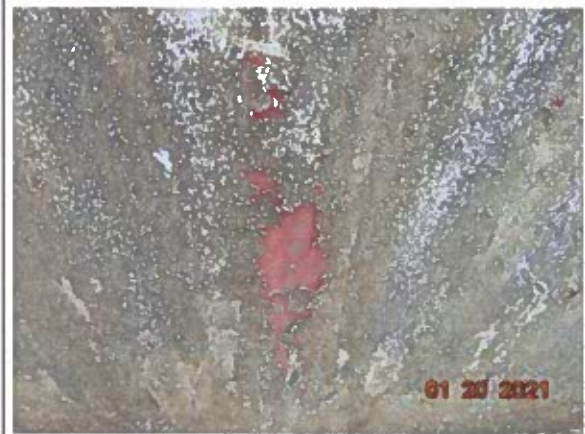
The shell coating was mostly intact with 5% of weld seams covered in corrosion cells. Some cells were brushed and little to no coating remained.

#8 Delamination on lower shell rings

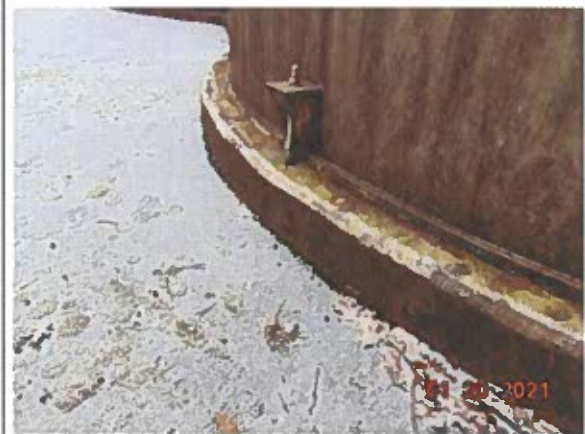
#9 Typical view of tank foundation

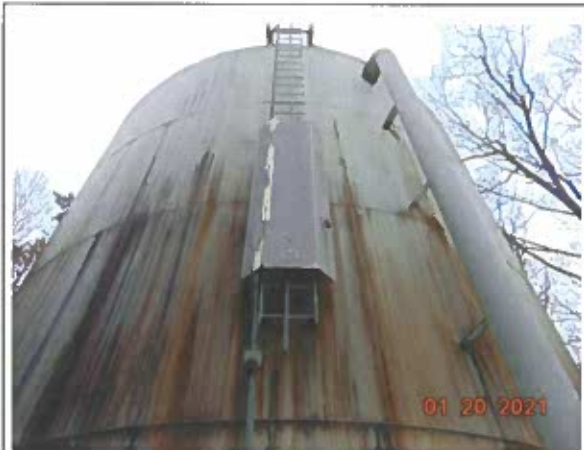
The ladder was intact. No deformations or corrosion was observed.

#13 Tank ladder

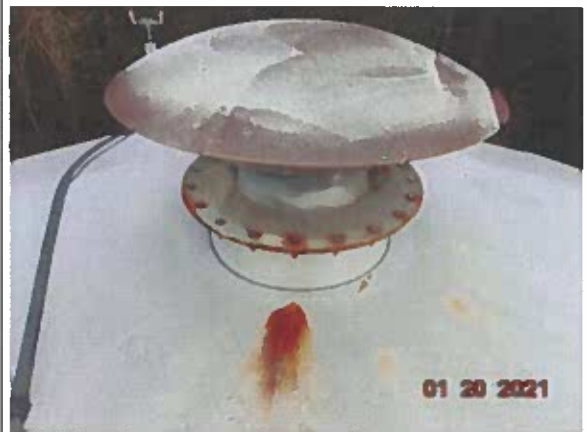
The roof vent had an intact fine mesh screen. Some of the bolts have corrosive staining around them but there were no signs of any perforations into the tank.

#17 Roof vent overview and corrosive staining

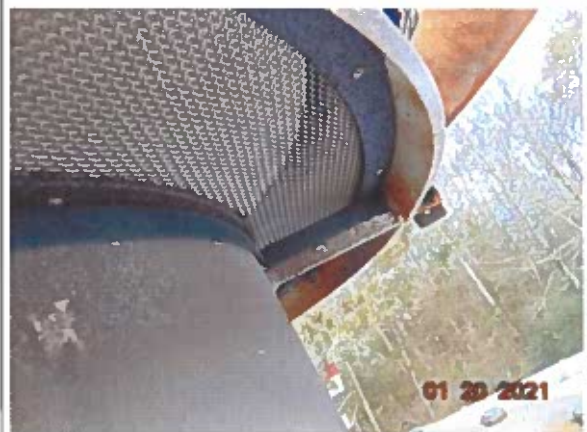
#18 Roof vent with intact fine screen

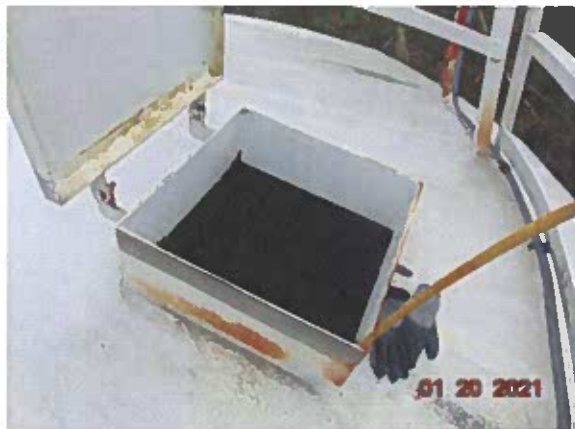
The roof hatch showed no signs of any perforations and no signs of leakage were found. The hinges allowed the hatch to move freely.

#20 Roof access hatch

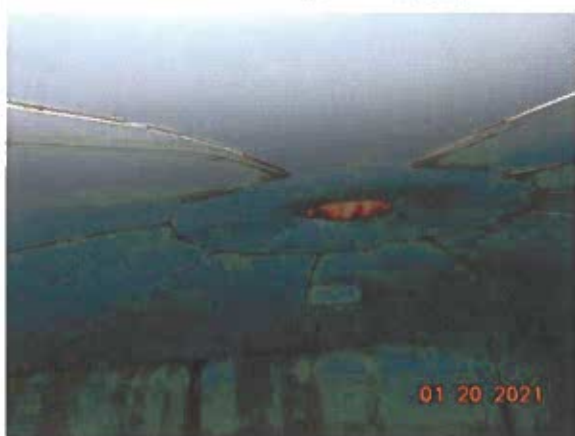
The roof had 30% corrosion focused along weld seams. No large areas of delamination were noted.

#21 Interior view of roof

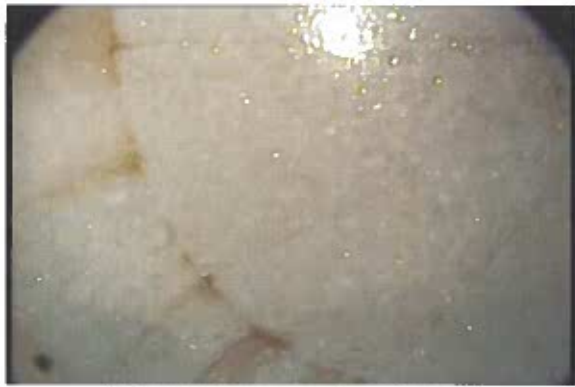
0:58 Typical view of roof plates

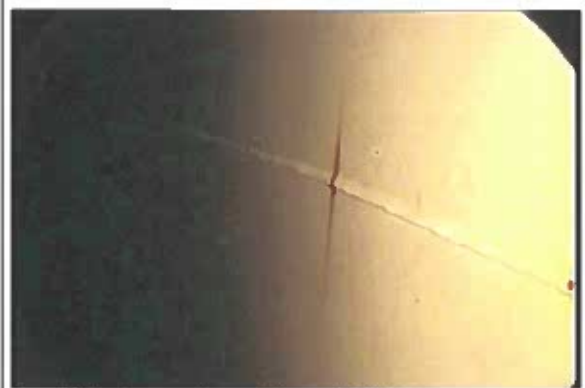
4:49 Corrosive staining from weld seam

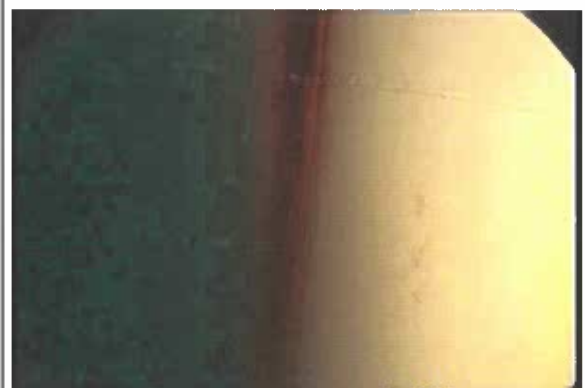
5:29 Staining on upper shell rings

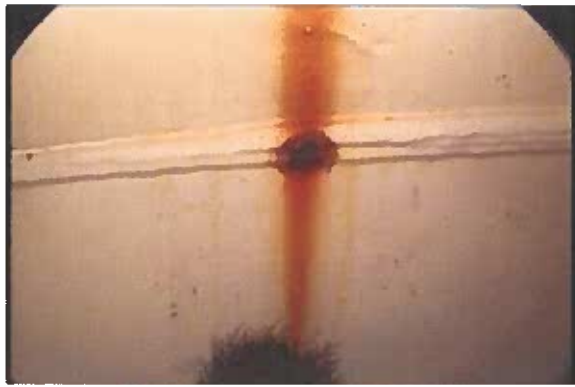
6:52 Brushed corrosion cell

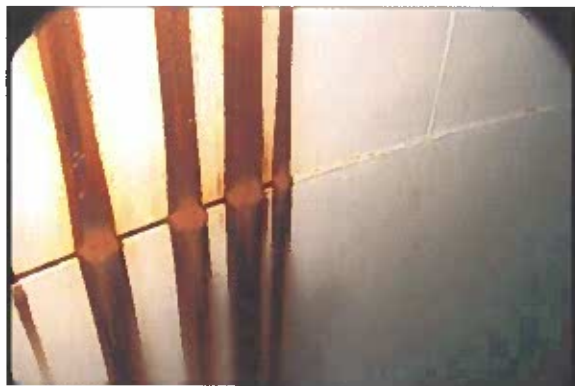
9:38 Corrosion cells on lower shell rings

An impressed current cathodic protection system (ICCP) should be installed to prevent metal loss of the submerged portions of the tank.

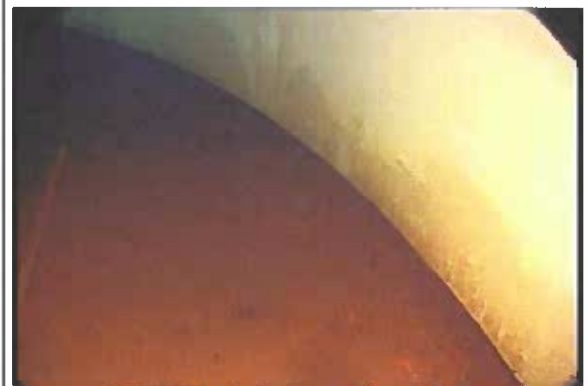
From what could be observed no corrosion cells or delamination was identified on the tank floor.

12:39 Typical view of tank floor

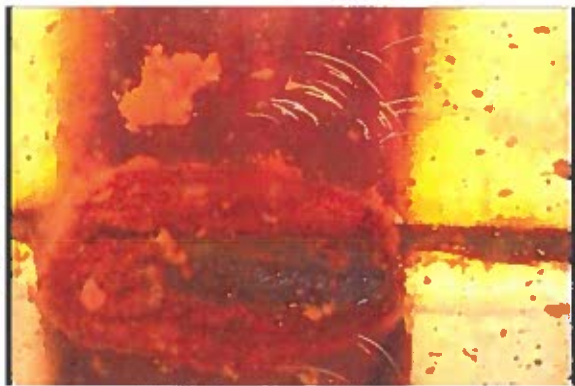
11:06 Exposed weld seam

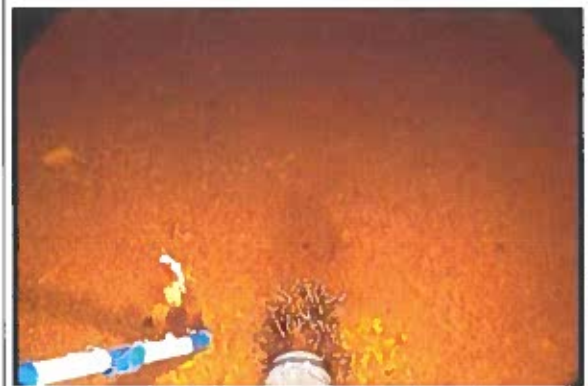
A 1/8-in layer of sediment has accumulated across the floor of the tank.

14:02 Sediment depth of 1/8"

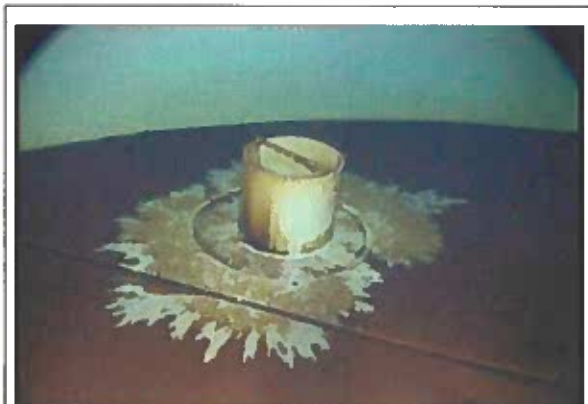
14:57 Inlet/outlet pipe with sediment ring
