WPCA

HAND OUTS - AMENDED

**Town of New Hartford - 175k GST
Water Storage Tank Inspection**

CorrTech Report No. 14845-FOR-01-1

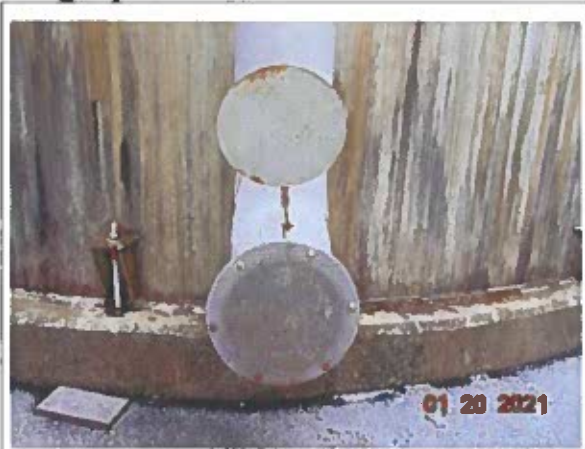
The overflow has an interior weir funnel. The pipe exits the top of the tank next to the ladder and runs down the side of the tank towards the ground where it discharges. The pipe is equipped with a flapper valve and has an intact fine and coarse mesh screen.

#4 Overflow with flapper valve and intact screen

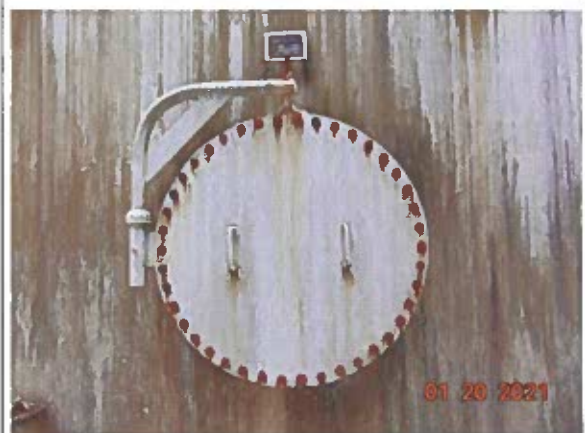
The tank has two shell manholes. All bolts are engaged on both and no signs of any leakage were identified.

#5 Shell manhole

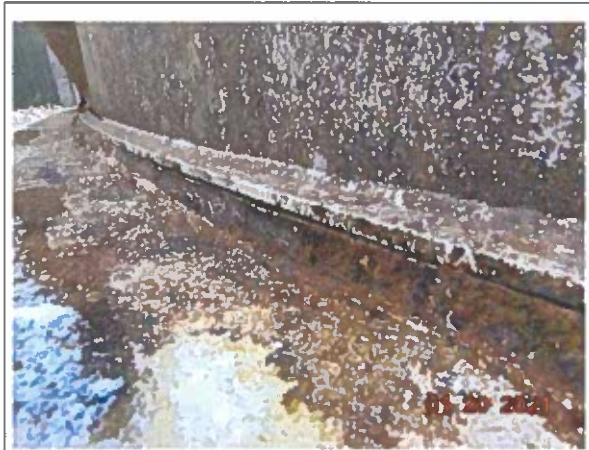
The tank foundation was free from any cracking or spalling. The calking under the chime plate was covered in biological growth and bio-staining but was intact.

#10 Typical view of chime grouting

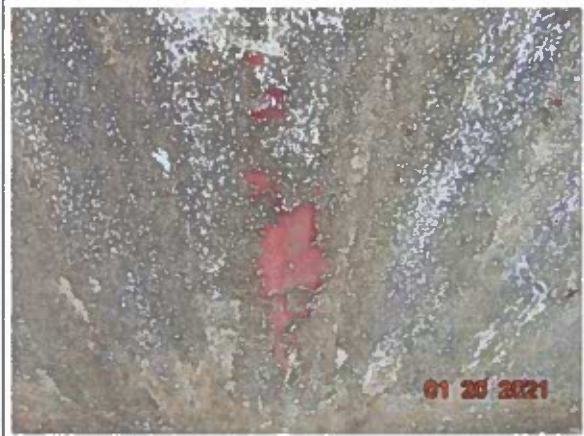
The exterior shell coating was mostly intact with only 1% suffering from delamination. 40% of the shell was covered in biological growth.

#8 Delamination on lower shell rings

Exterior shell and roof surfaces should be cleaned using high pressure water to remove biofilm that is unsightly and may contribute to degradation of the coating system.

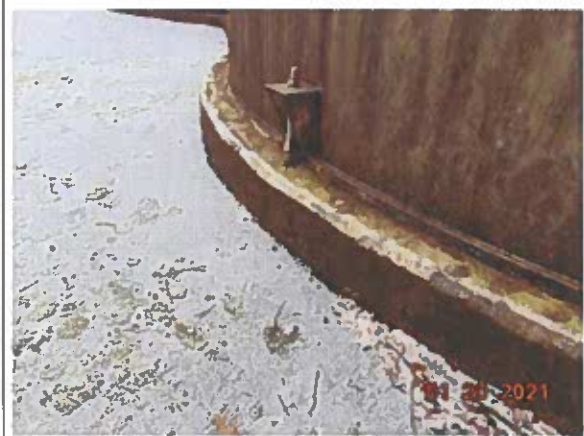
#9 Typical view of tank foundation

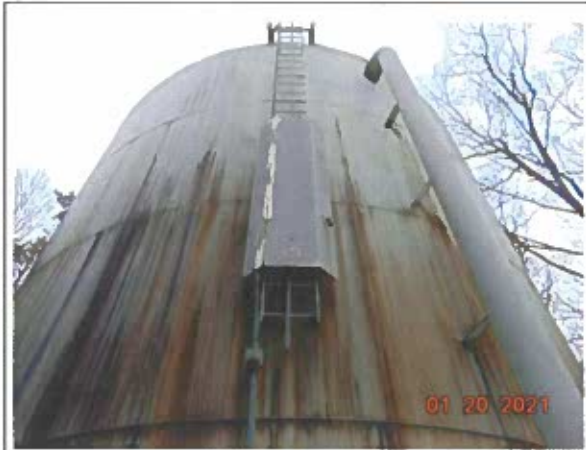
The ladder was intact. No deformations or corrosion was observed.

#13 Tank ladder

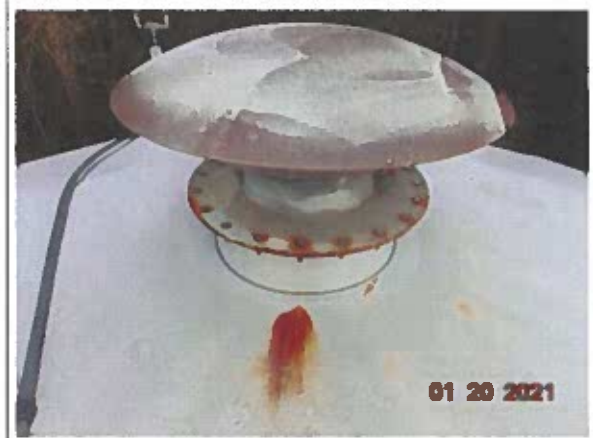
The roof vent had an intact fine mesh screen. Some of the bolts have corrosive staining around them but there were no signs of any perforations into the tank.

A single area of corrosive staining was noted near the roof vent while the rest of the roof coating was free from any corrosion or delamination. Minor chalking was noted,

#17 Roof vent overview and corrosive staining

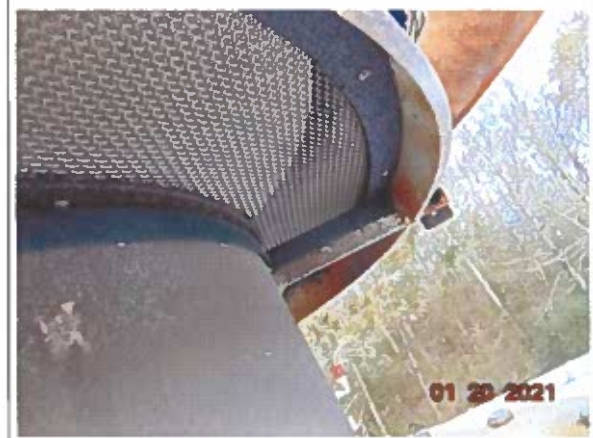
#18 Roof vent with intact fine screen

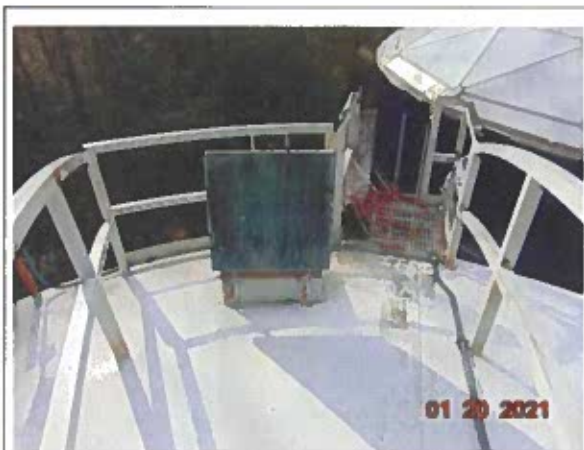
The handrails enclose the roof access hatch and lead up towards the roof vent. Some minor corrosion was observed but the handrails were still intact. They meet all OSHA standards.

#19 Overview of roof access hatch and tank ladder

In order to be in compliance with OSHA Standard 1910.23(a)(2) all railing openings or platform pass through openings shall be equipped with a self-closing swing gate. Although this standard strictly addresses new construction after 11/19/2018 it is advisable to modify existing tanks with this safety device. If existing ladders are modified or replaced on an existing tank then this new standard applies.

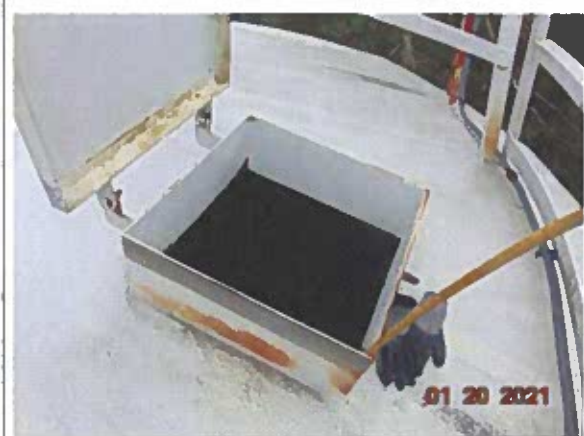
The roof hatch showed no signs of any perforations and no signs of leakage were found. The hinges allowed the hatch to move freely.

#20 Roof access hatch

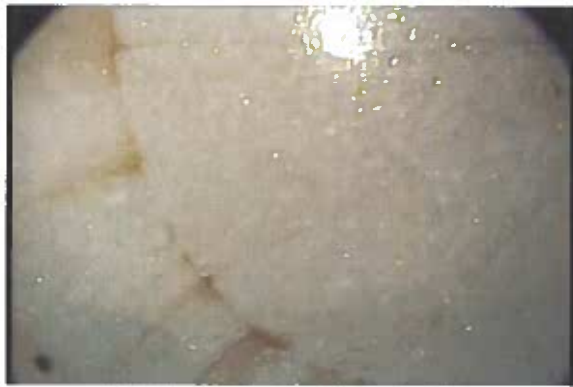
The roof had 30% corrosion focused along weld seams. No large areas of delamination were noted.

0:58 Typical view of roof plates

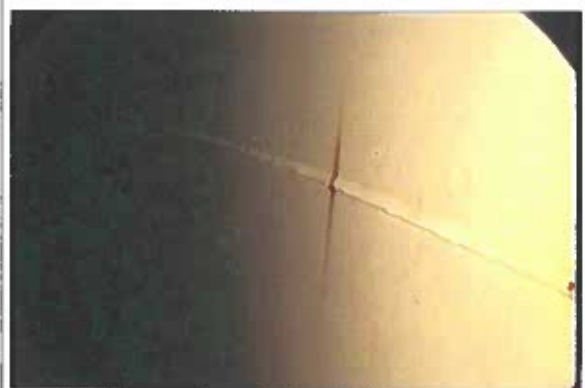
The shell coating was mostly intact with 5% of weld seams covered in corrosion cells. Some cells were brushed and little to no coating remained.

4:49 Corrosive staining from weld seam

An impressed current cathodic protection system (ICCP) should be installed to prevent metal loss of the submerged portions of the tank.

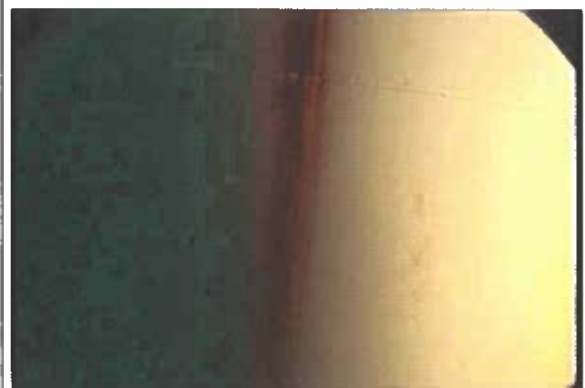
5:29 Staining on upper shell rings

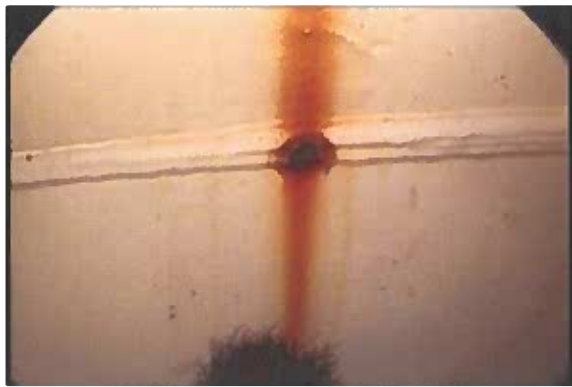
6:52 Brushed corrosion cell

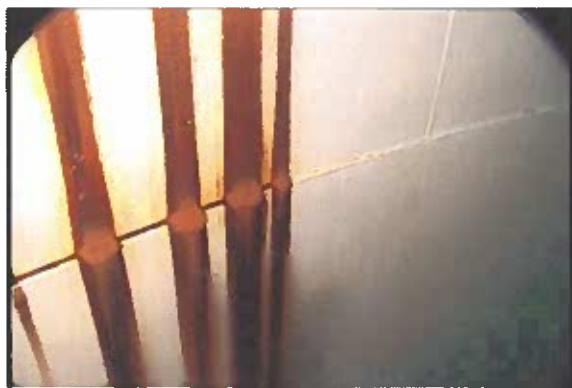
9:38 Corrosion cells on lower shell rings

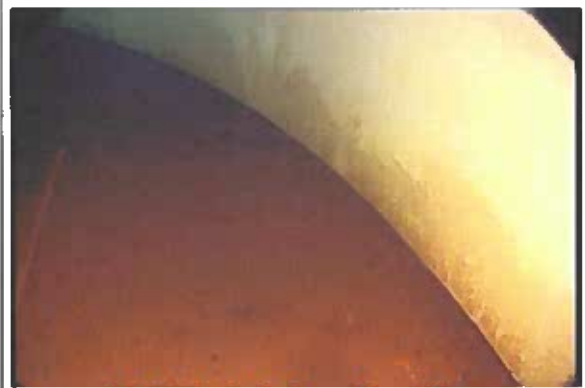
From what could be observed no corrosion cells or delamination was identified on the tank floor.

12:39 Typical view of tank floor

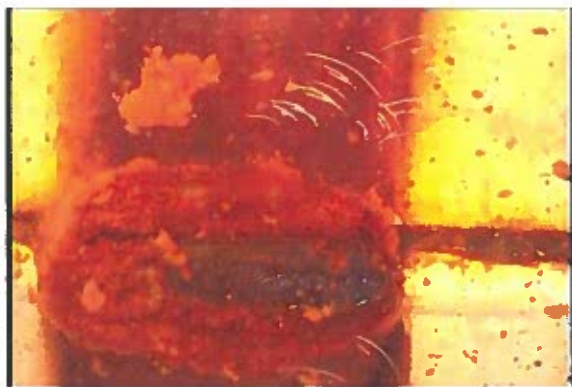
11:06 Exposed weld seam

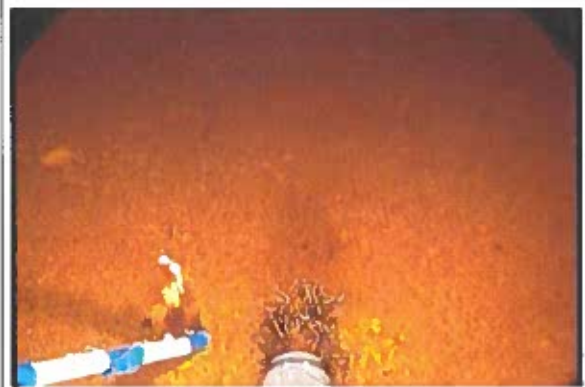
A 1/8-in layer of sediment has accumulated across the floor of the tank.

There was an even 1/8" layer of sediment across most of the tank floor. The sediment around the inlet/outlet pipe had been disturbed exposing the floor coating.

14:02 Sediment depth of 1/8"

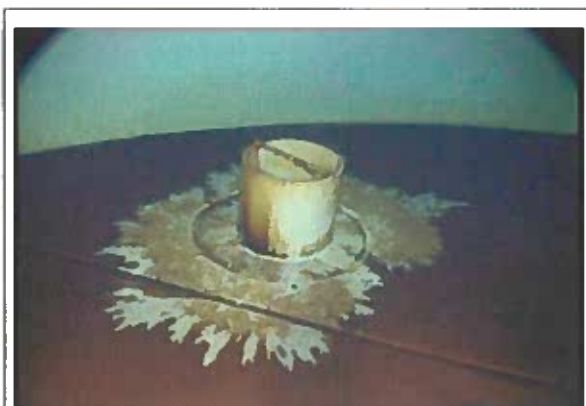
The inlet/outlet pipe penetrates the tank floor and is equipped with a sediment ring. The overflow has a funnel at the top of tank near the roof access hatch.

14:57 Inlet/outlet pipe with sediment ring

A mixing system should be considered to prevent stratification and other short-circuit issues that affect overall water quality.
