Subject: Aquastore Tank Inspection Report
New Hartford, CT
Model 5033 MIP 8900015

New Hartford, CT
Aquastore Water Storage Tank Inspection
Dry Inspection – 4/15/15
Model 5033; 491,000 Gallons; MIP - 8900015

On 4/15/15, Statewide Aquastore, Inc conducted an interior and exterior inspection of the 491,000 gallon Aquastore® water storage tank noted above. This inspection is to provide information regarding the overall condition of the tank. The tank has been in service for approximately 25 years. It was installed and put in service in 1990.

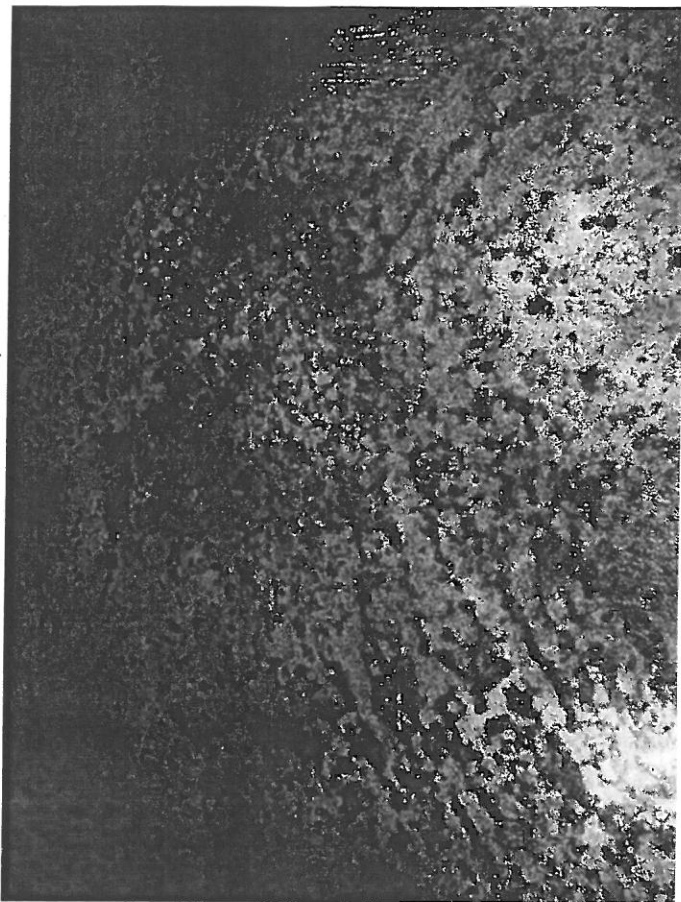
Clean Floor

- There are no visible cracks in the floor and it appears to be in good condition.
- The concrete floor appears to be in excellent condition.

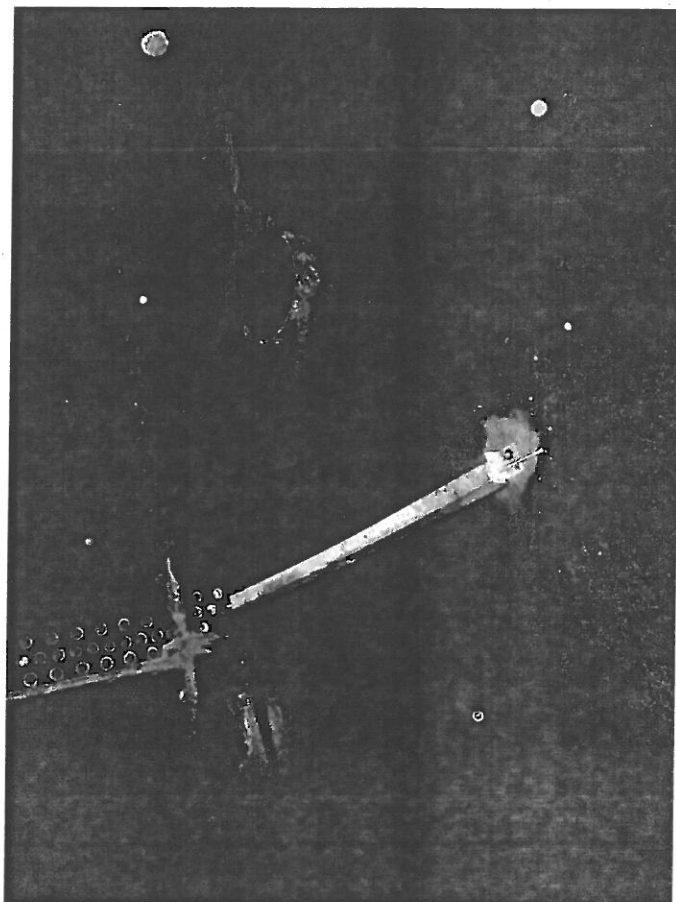
CP Anode 1

Other Comments: A Cathodic Protection (CP) System was installed in this tank during the inspection. The system consists of 6 magnesium sacrificial anodes. The system should be tested every 3 years to ensure it is providing the correct amount of protection to the wetted surfaces of the tank.

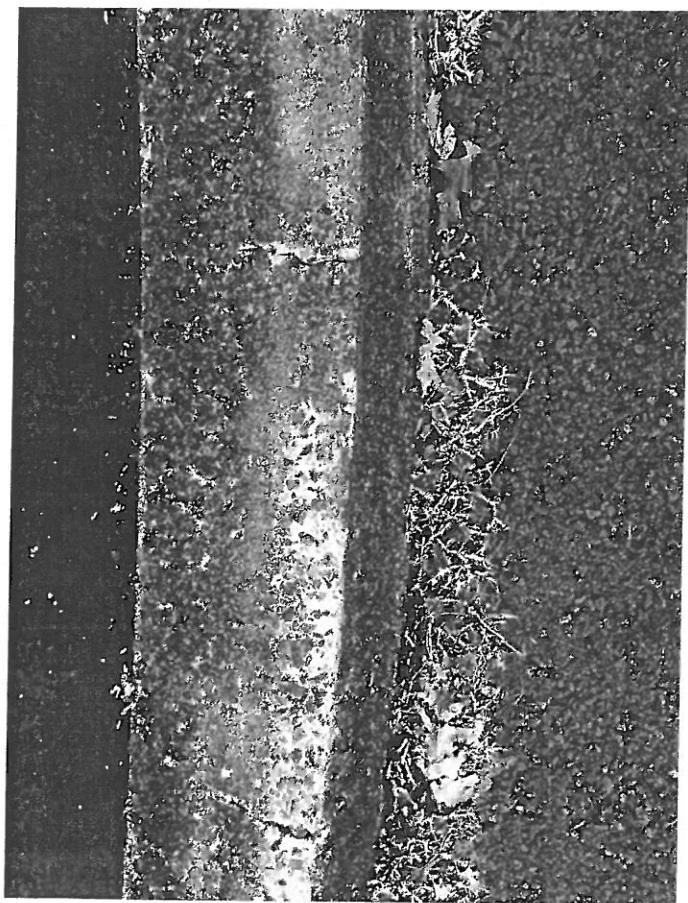
Curb

- Minor radial cracking is present in the curb area. These cracks pose no structural concern and no repairs are necessary at this time.
- Minor weathering is exhibited on the concrete surface.

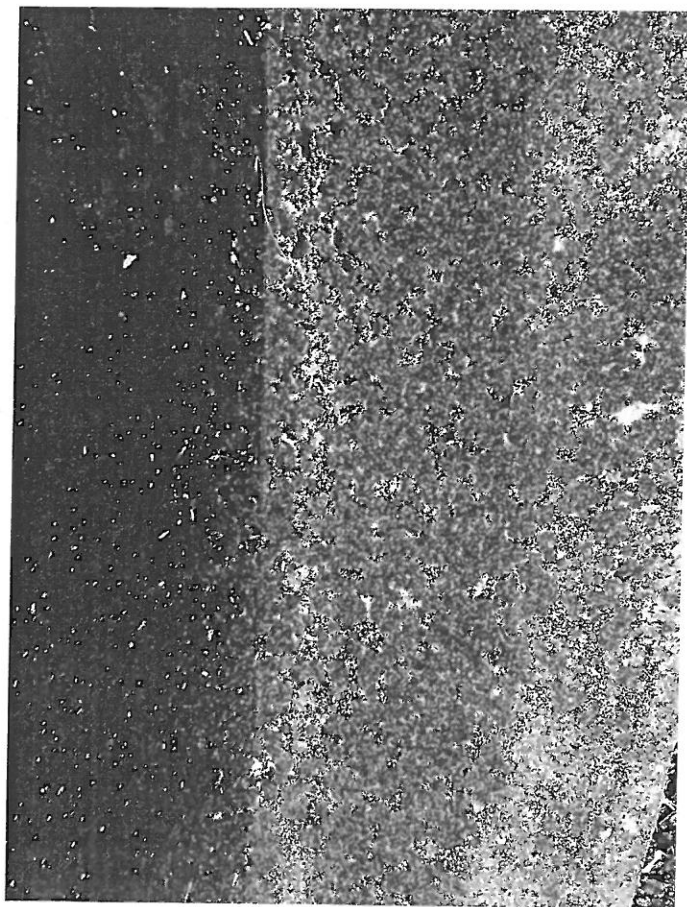
Exterior Bottom Seal

- There is no perimeter seal between the sidewall and the concrete curb. We recommend that one be installed.

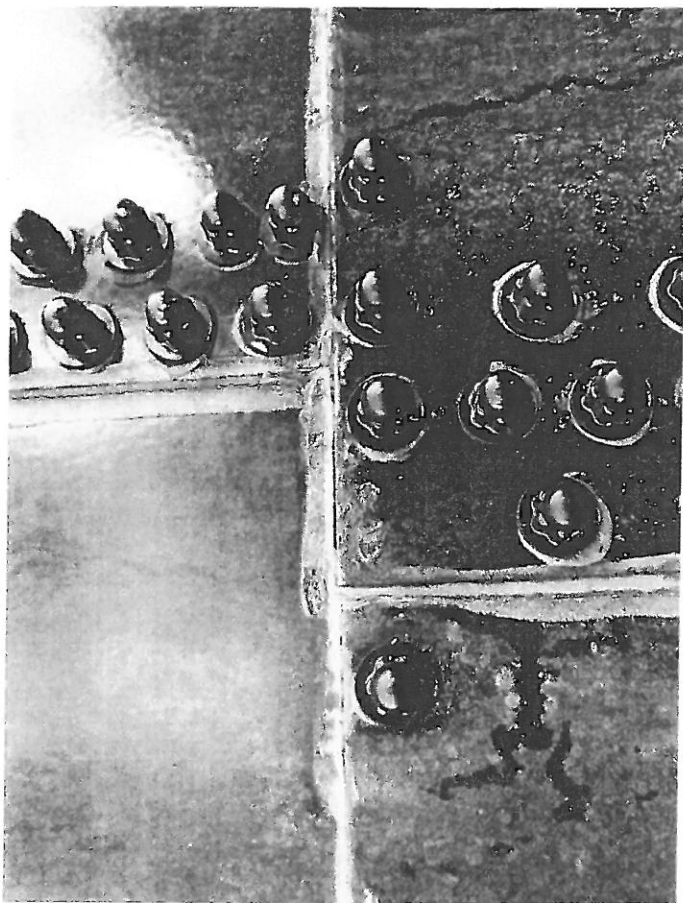
Exterior Exposed Seam 1

- Manus sealant was used in the construction of this tank. The sheet edges are starting to show and some sidewall streaking is taking place. We recommend that the sheet edges be cleaned and resealed.

Other Comments: The exterior sheet edges are exposed and are beginning to corrode. The edges should be resealed. By installing a new sealer fillet, you are providing a layer of protection against the elements and enhancing both the aesthetics and longevity of the tank.

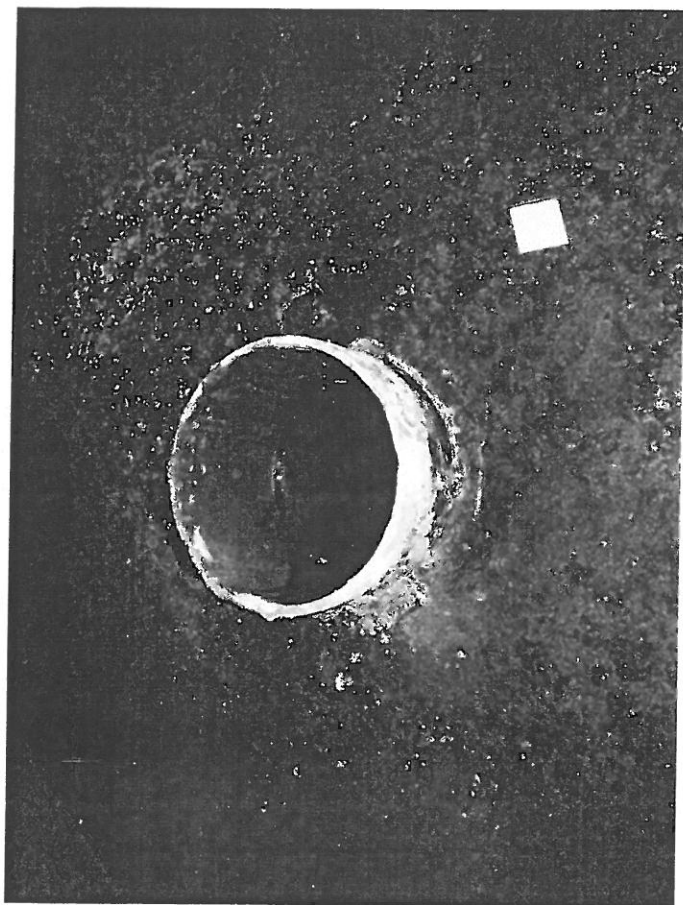
Inlet-Outlet Pipe

- A 12 inch DI inlet/outlet pipe is present in the floor of this tank.
- Minor corrosion is present on the exposed edge of the pipes.

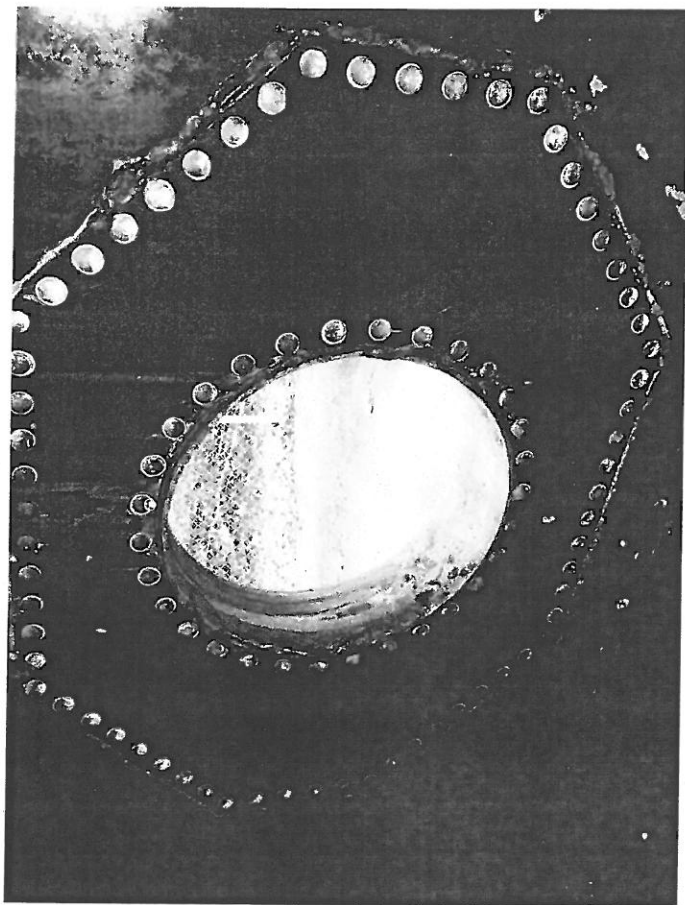
Interior of Manway 1

- Some minor corrosion on the bottom manway was seen.
- The "R" plates show some sign of corrosion. It is possible that loss of material is occurring.
- The neck weldment shows some signs of corrosion.

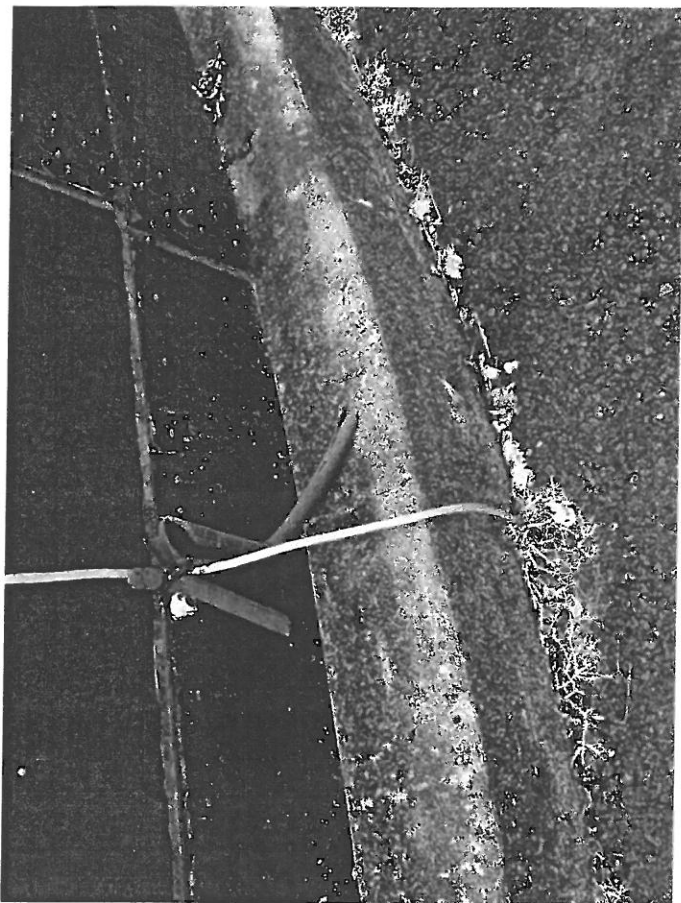
Lightning Protection

- There is lightning protection on this tank.

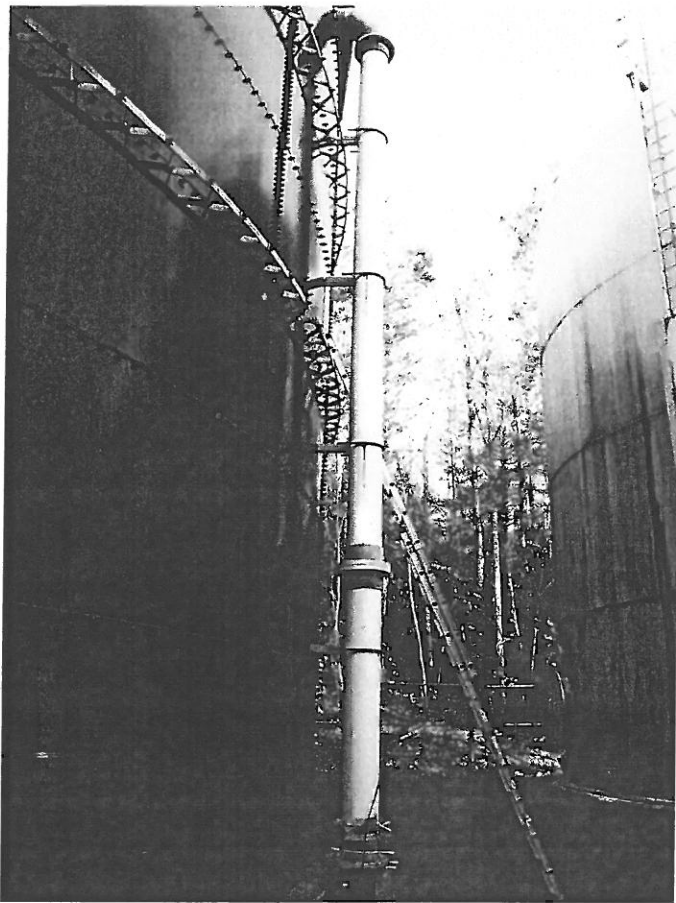
Overflow Before Repair

Other Comments: No weir box is installed on this tank. The overflow pipe attached to the tank with a 90 degree elbow.

While onsite, three existing overflow pipe brackets were relocated and four new pipe brackets were added. Two patch plates were installed inside the tank at the points where two of the old brackets were mounted. A pipe plug was also removed from the sidewall of the tank and a structure bolt inserted to provide a permanent fix to a prior leak. The interior sidewalls and floor were pressure washed. The sediment was removed and disposed of on site.

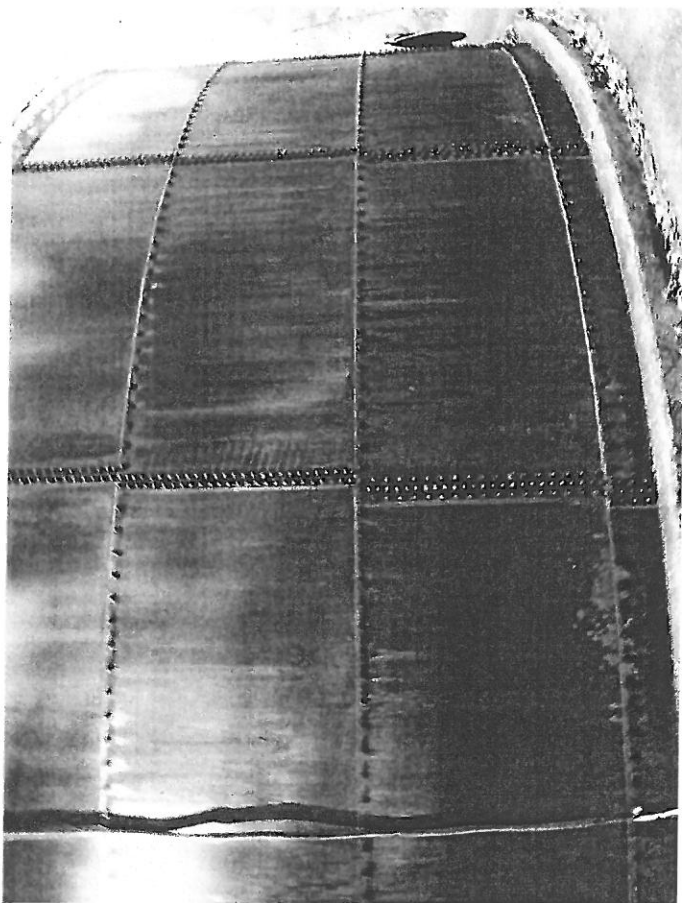
Pollen - Algae Accumulation

- Sidewall sheets, sheet edges, fillets, joints, hardware, etc. are in good condition.
- Some algae growth was visible on the sidewalls. This is not a structural concern, but should be cleaned off.

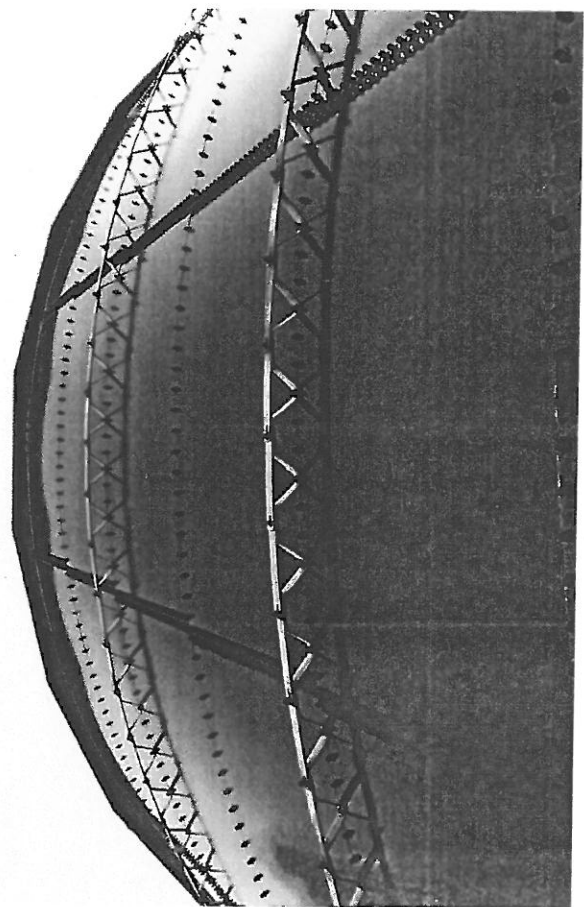
Web Trusses

- The tank was constructed with (2) three inch galvanized web-truss rings securely bolted in place. These appear to be in good condition.
