Water Tank Inspection Report
For
Town of New Hartford WPCA
Of the

175K Welded GST
New Hartford, CT

May 18, 2010

♦ **Tank# 2 175K-Welded Standpipe**

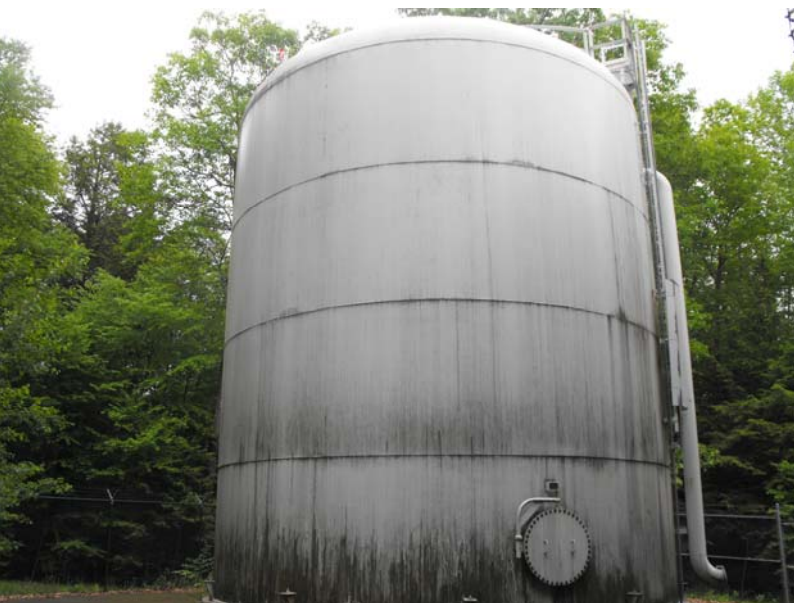
001.JPG
04/15/2010
Overall view of tank.

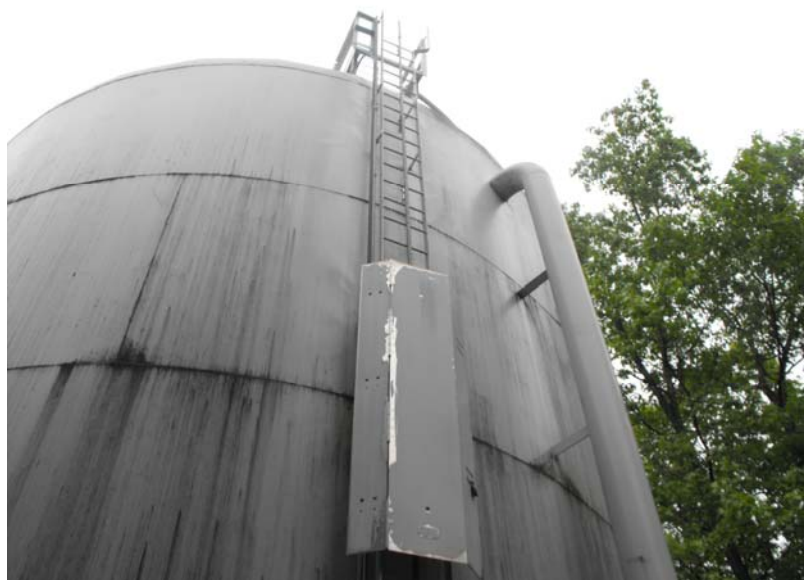
The tank has a 16-inch wide ladder with a 12-inch rung-to-rung spacing, a 7-inch toe clearance. The ladder base is 10-feet from grade but the ladder guard covers up to the 16-ft level. The ladder has an anti-climb shield and rail climb but no safety cage see DP# 2.

002.JPG
04/15/2010
Exterior shell ladder equipped with rail climb and anti-climb.

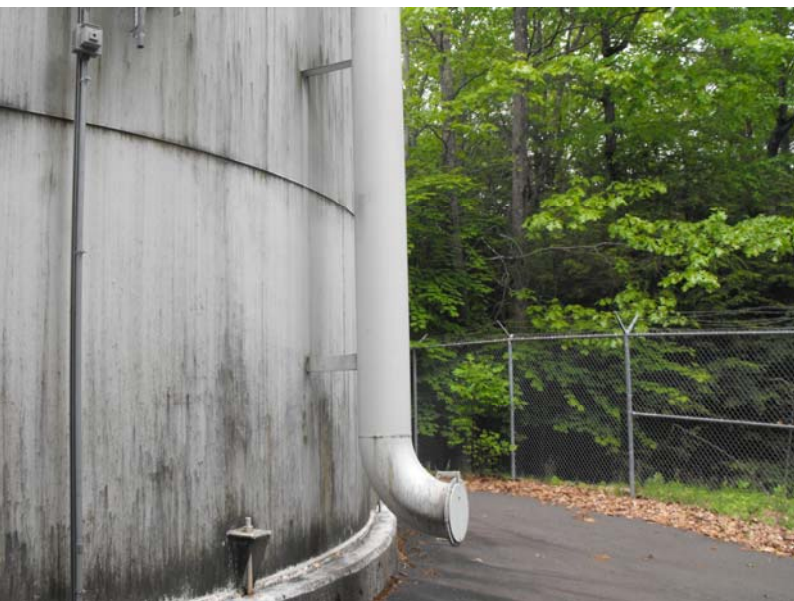
The overflow pipe measures 12-inches in diameter and extends from a top shell penetration to just above grade. The outlet discharges adjacent to the tank into a catch basin and is equipped with a fine mesh screen see DP# 2-4.

003.JPG
04/15/2010
Overflow outlet equipped with flapper valve

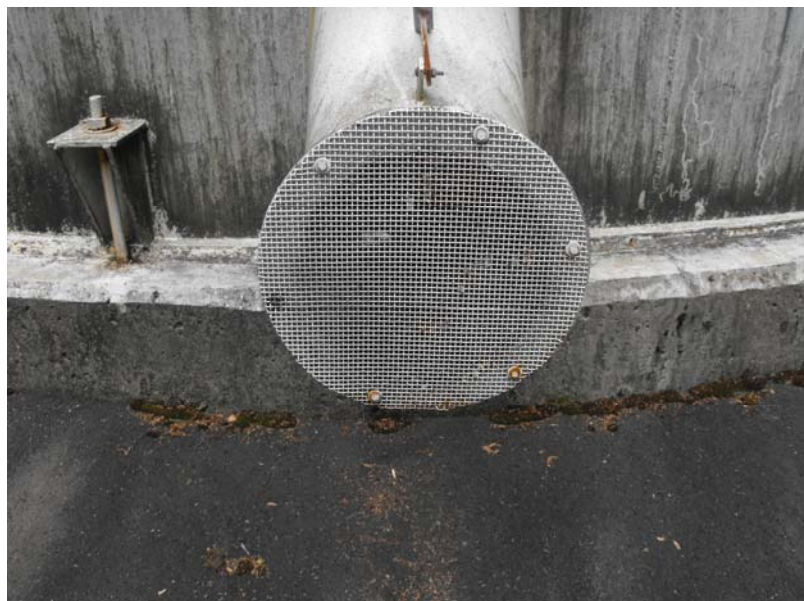
004.JPG
04/15/2010
Fine screening on overflow outlet.

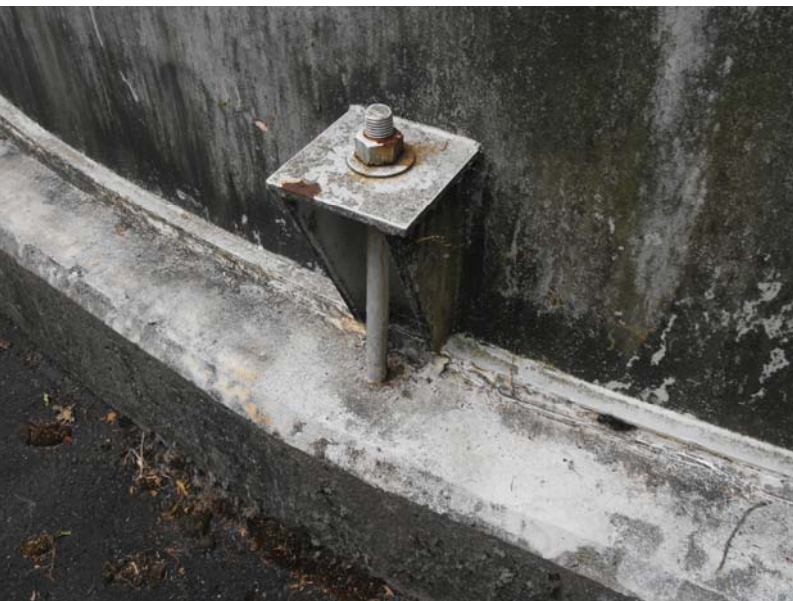
The tank is secured to the foundation with (10) anchor bolts and ½-inch chairs. Light surface corrosion was found on the anchor nuts, bolts and chairs see DP# 5-7.

005.JPG
04/15/2010
Spot corrosion area on anchor chair.

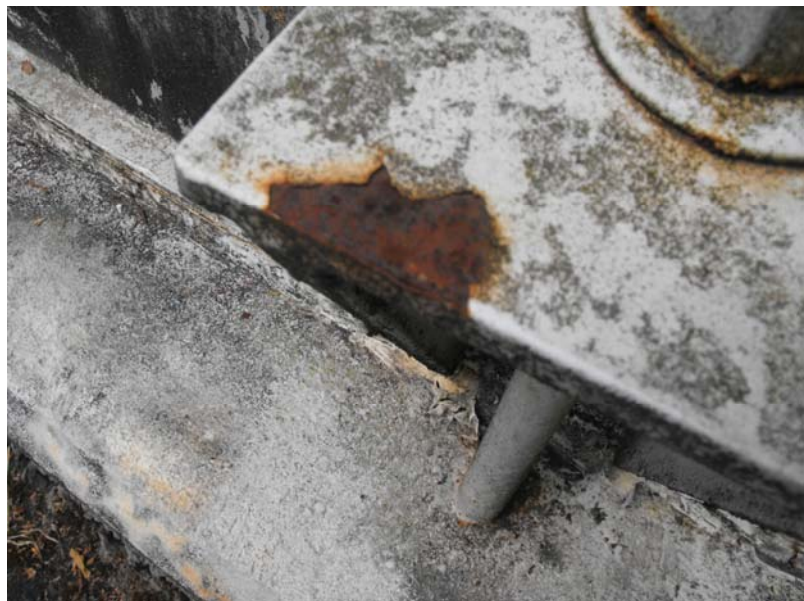
006.JPG
04/15/2010
Closeup of spot corrosion area on anchor chair.

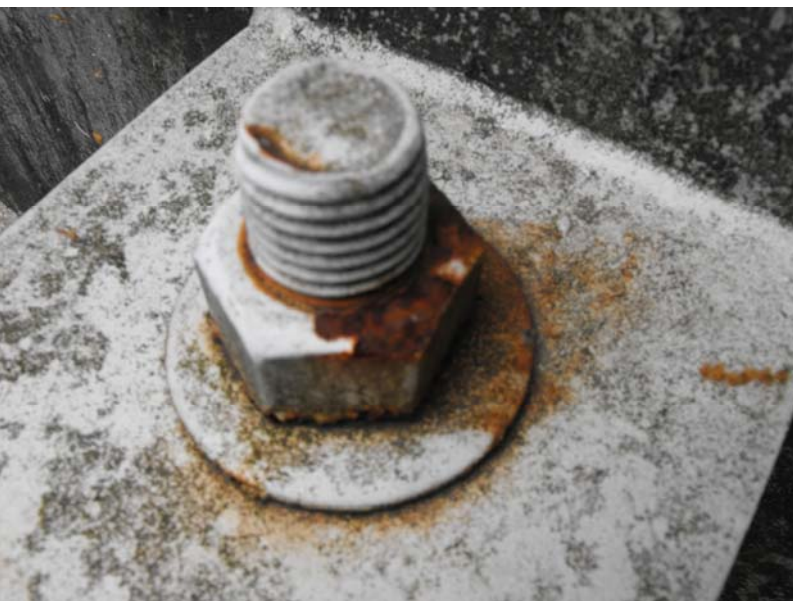
007.JPG
04/15/2010
Surface corrosion on anchor nut and bolt.

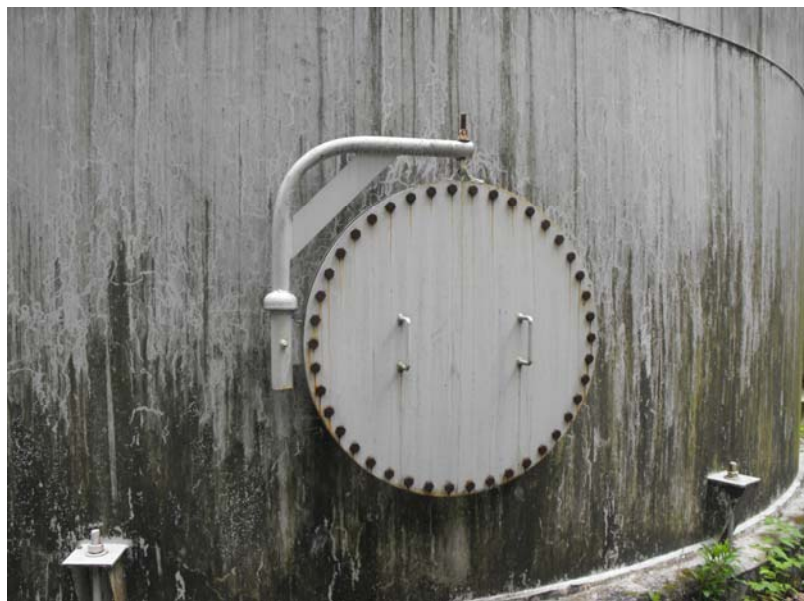
008.JPG
04/15/2010
36-inch round shell access hatch (1 of 2)

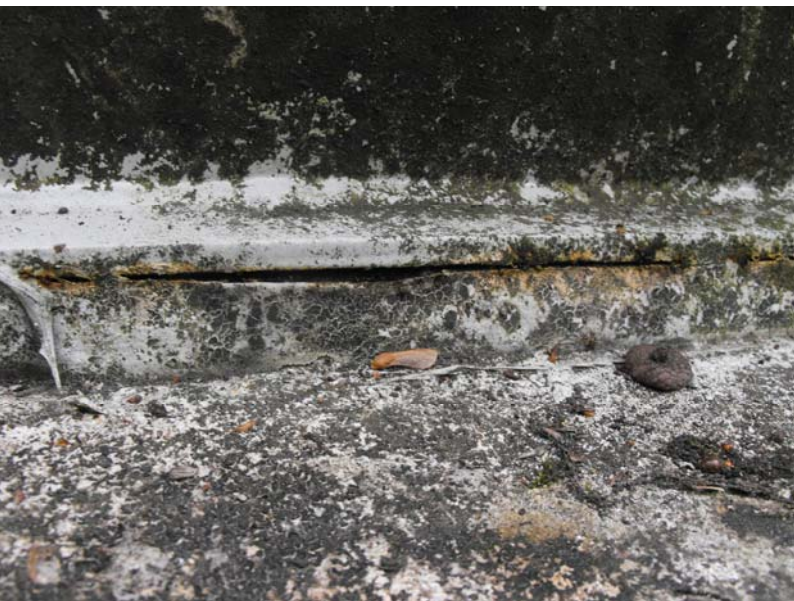
The exposed foundation top and side faces are in good face with no major cracking or spalling locations. The grouting between the chime plate and the foundation top has started the shrink and pull away in isolated locations, see DP# 9. Vegetation overgrowth was found around the tank base.

009.JPG
04/15/2010
Slight grout separation area under chime plate.

The grouting between the chime plate and foundation is starting to separate from the chime in small spots but does not require repair at this time. The vegetation growing out of the foundation should be removed.

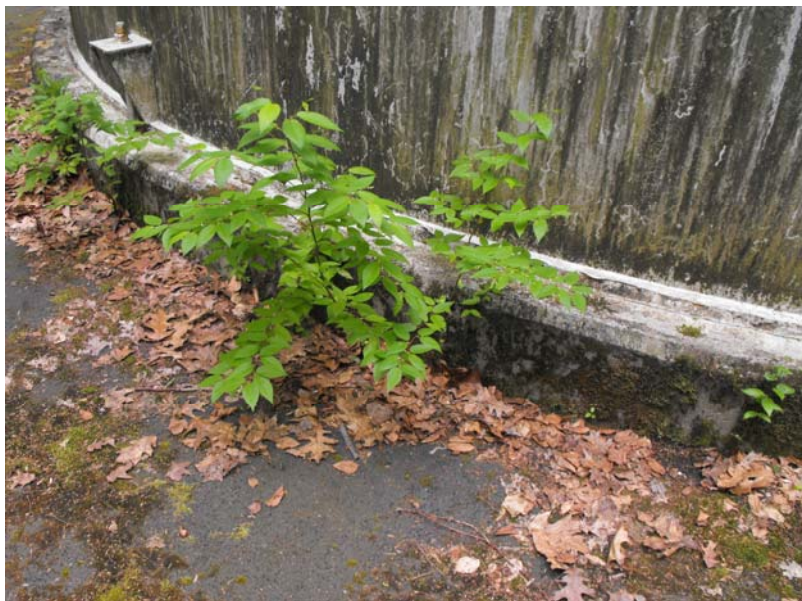
010.JPG
04/15/2010
Vegetation growing near foundation.

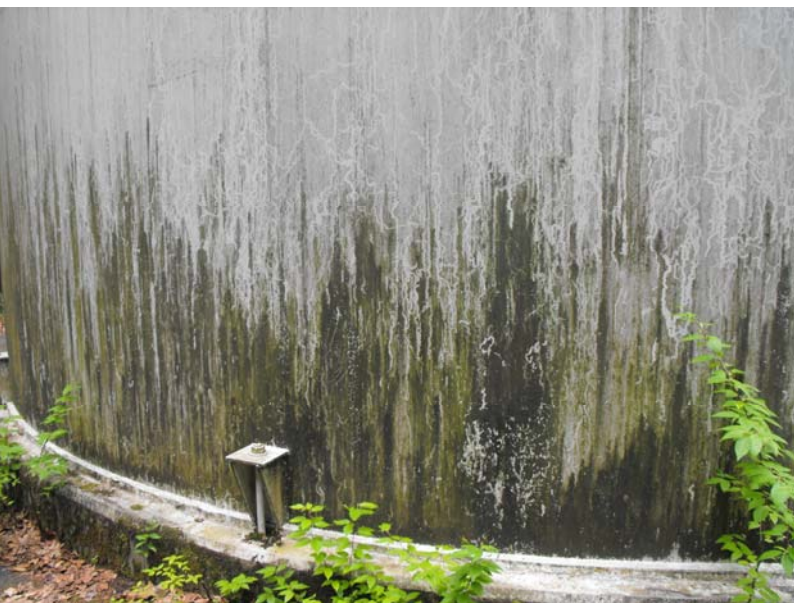
The shell coating is in good condition with light chalking and moderate mildew staining. The mildew staining is darkest on the first shell course but is prolific on all four shell rings see DP# 11. Overall the majority of the shell coating is intact and protecting the underlying substrate.

011.JPG
04/15/2010
Moderate mildew staining on tank base.

The exterior coating is in good condition but will need power washing to remove the mildew staining and sprayed with a bio-barrier material to resist future mildew growth.

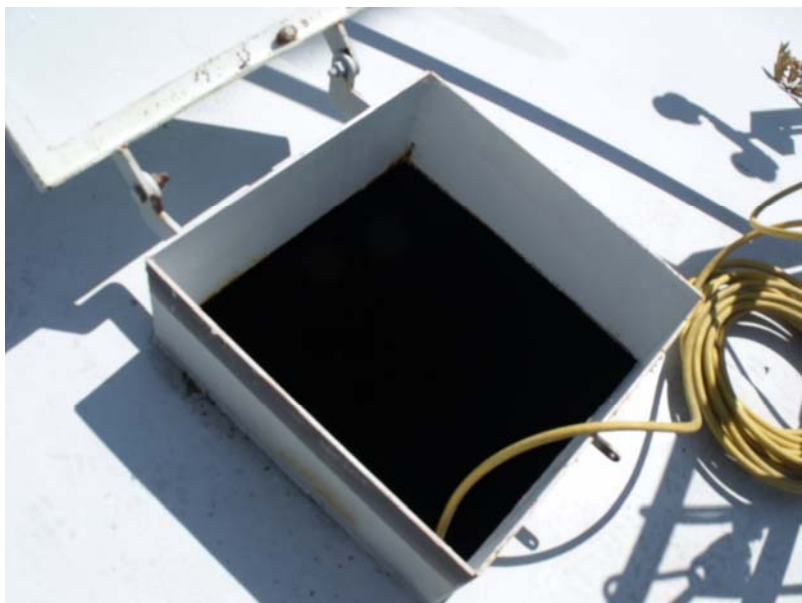
012.JPG
06/03/2009
24-inch roof hatch.

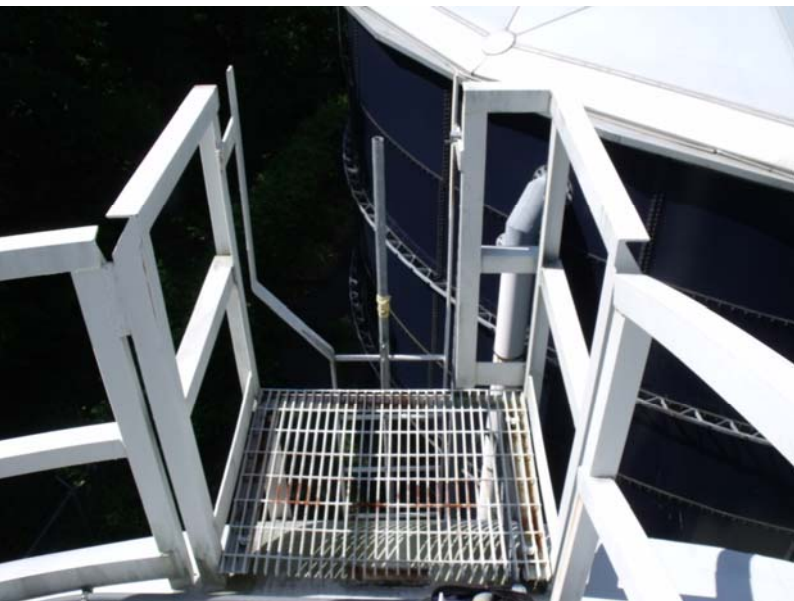
013.JPG
06/03/2009
42-inch roof railing equipped with mid-rail and toe kick.

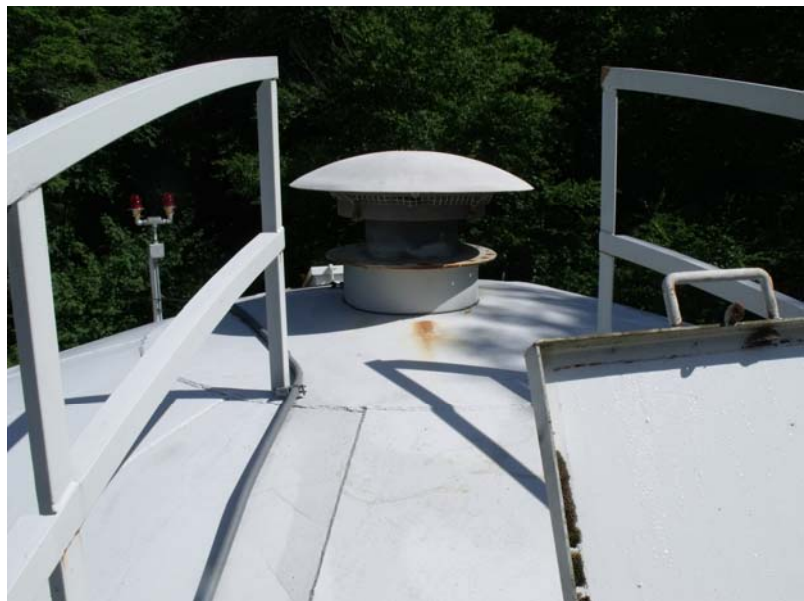
The roof is equipped with a railing system with a 42-inch tall top rail, a 21-inch mid-rail and a 4-inch toe kick see DP# 14.

014.JPG
06/03/2009
Roof safety railing and center roof vent

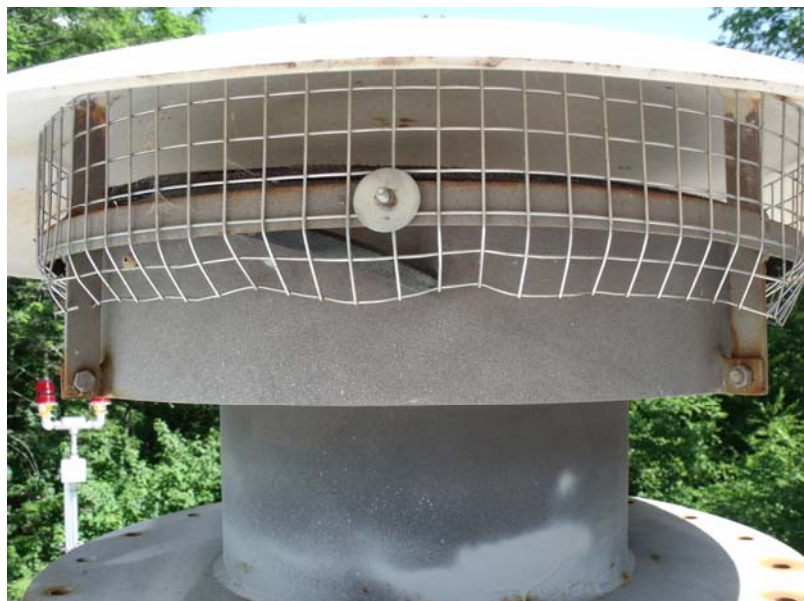
The tank is equipped with one dome capped, centrally located vent see DP# 15. The vent has a 16-inch collar diameter and a 22-inch vent cap to roof distance. The vent is equipped with an exterior coarse screen and interior fine mesh bug screen, which are in good condition, see DP# 16. New bolts were installed in the vent flange as part of the inspection.

016.JPG
06/03/2009
Coarse rscreen outside with fine mesh under cap. All bolts replaced at time of inspection.

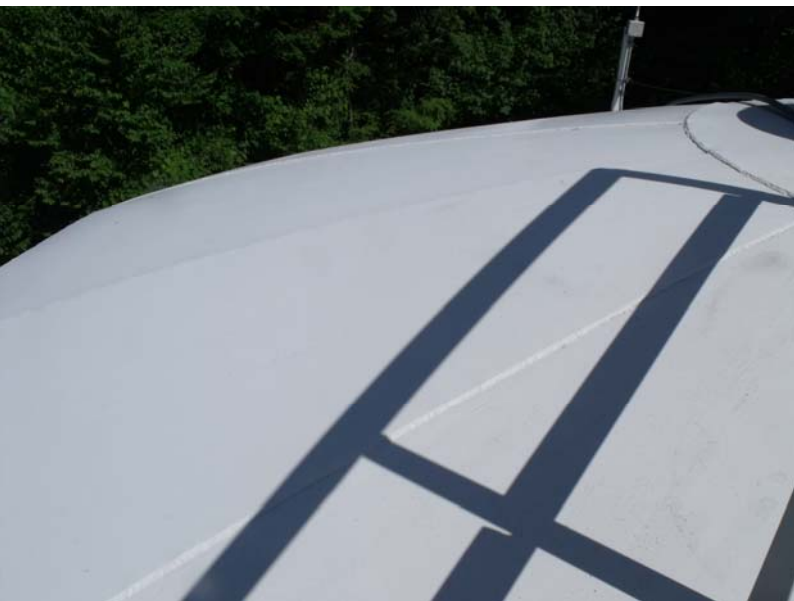
The exterior roof coating is in good condition with moderate chalking. The majority of the roof is intact and continuing to protect the underlying substrate see DP# 17&18.

017.JPG
06/03/2009
Left hand view of exterior roof from shell ladder

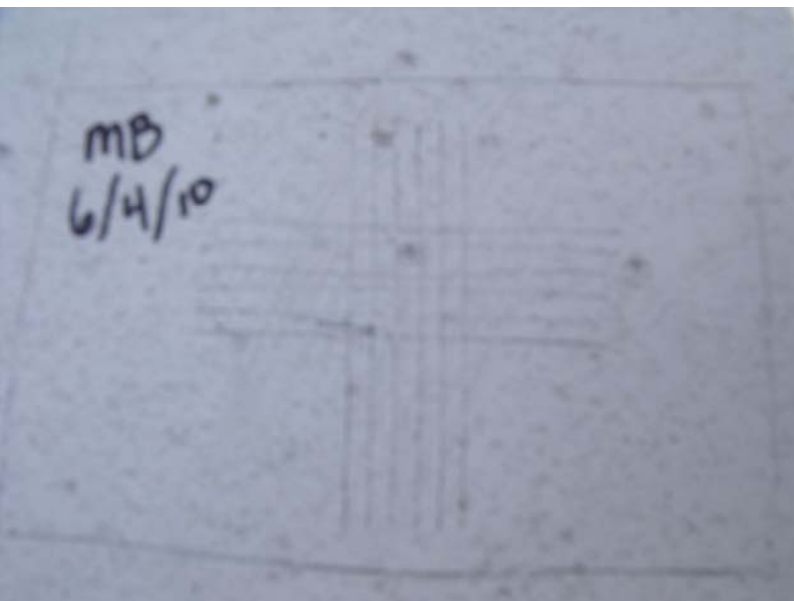
Adhesion test results were performed on the roof and according to ASTM D3359-02 method 'B'. A 4B rating was achieved between the topcoat and the primer and the primer to the substrate see DP# 19. The results show a properly performing coating system.

019.JPG
06/03/2009
Cross cut adhesion test taken on the exterior roof

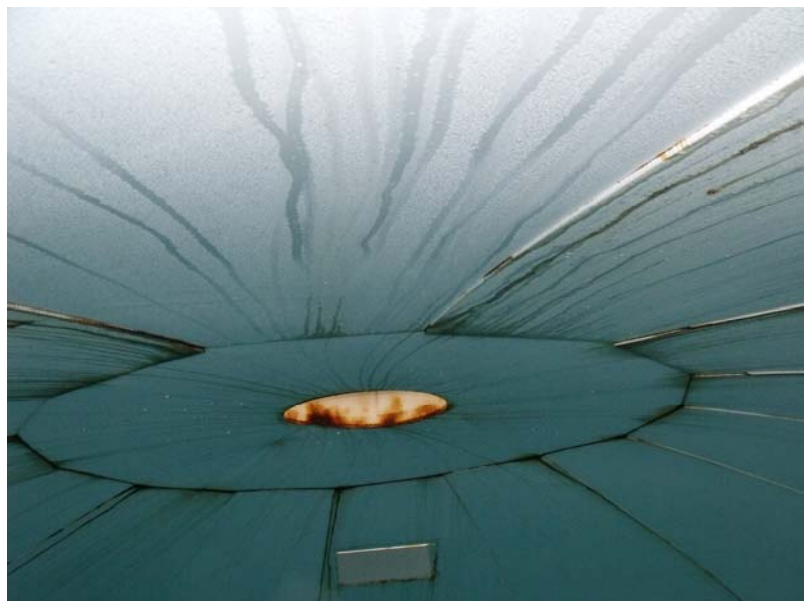
020.JPG
06/03/2009
Interior dollar plate with edge corrosion

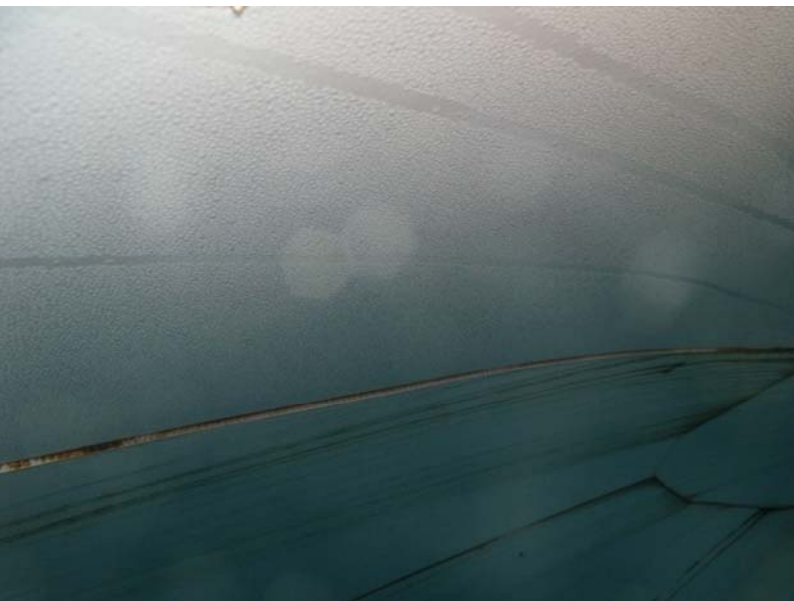
The domed roof is a self-supporting structure with exterior lap welded steel plates. The roof has numerous seam corrosion areas on all welds located around the central dollar plate and radial welds see VS# 3. The knuckle welds also have prolific seam corrosion and rust staining see VS# 2. No metal loss was found on the roof welds or components. The steel plates are in good condition with intact coating and only minimal surface corrosion see DP# 21&22.

021.JPG
06/03/2009
Edge corrosion on roof plate seams

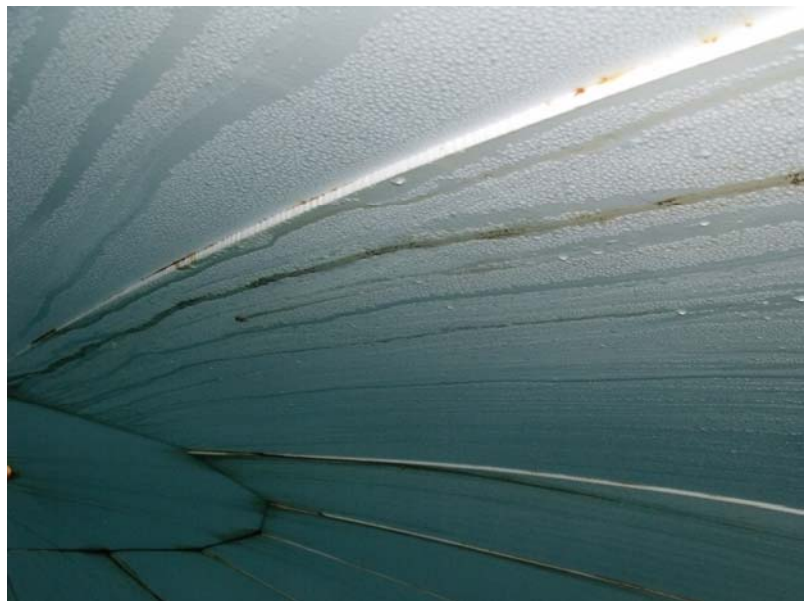
022.JPG
06/03/2009
Right hand view of interior roof from roof hatch

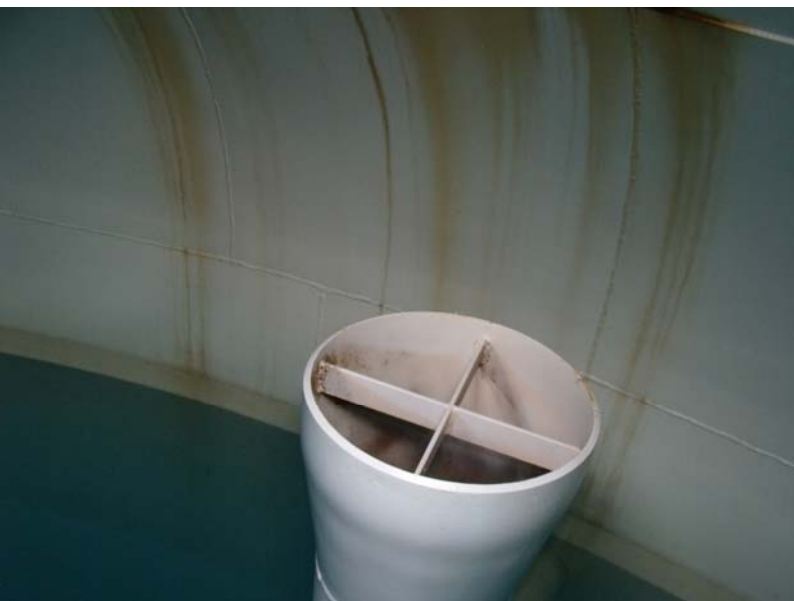
023.JPG
06/03/2009
Interior overflow pipe

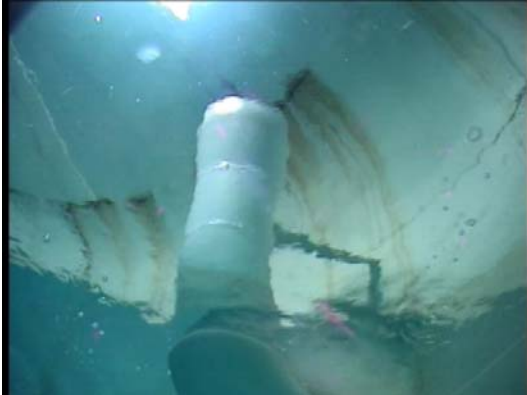
VS # 1: Overflow elbow (Time: 00:52)

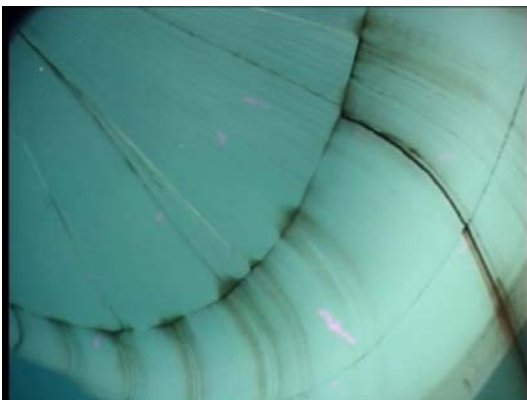
VS # 2: Seam corrosion and rust staining on knuckle welds (Time: 01:35)

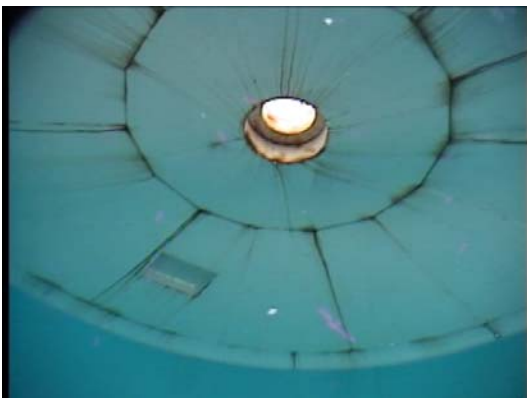
VS # 3: Center dollar plate with seam corrosion (Time: 03:20)

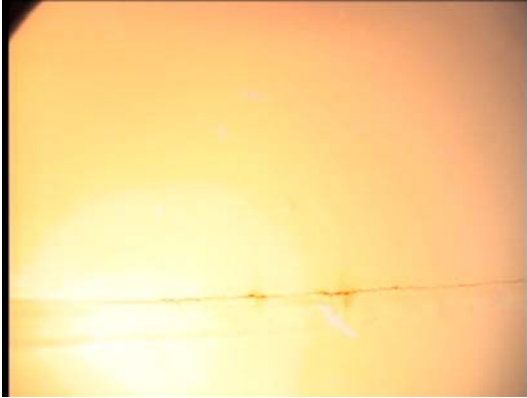
The shell coating was in very good condition except for the first horizontal weld above the floor. Numerous corrosion cells were found throughout entire circumference of this weld with some pitting see VS# 6-8. It appears that all other welds on the tank interior were stripe coated prior to the coating application see VS# 5. Only one other area of minor corrosion was found on the upper portions of the tank see VS# 4. The shell to floor seam was in very good condition see VS# 9.

VS # 4: Minor area of seam corrosion on horizontal weld
(Time: 09:53)

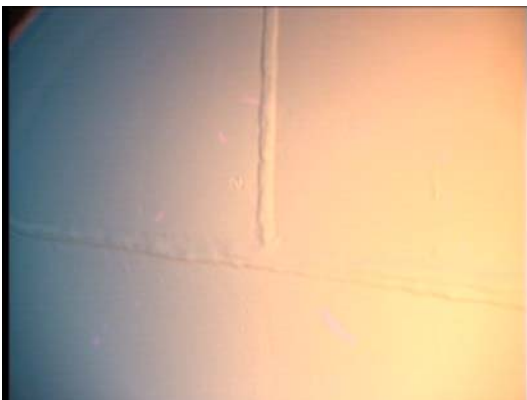
VS # 5: Typical good shell coating condition (Time: 12:06)

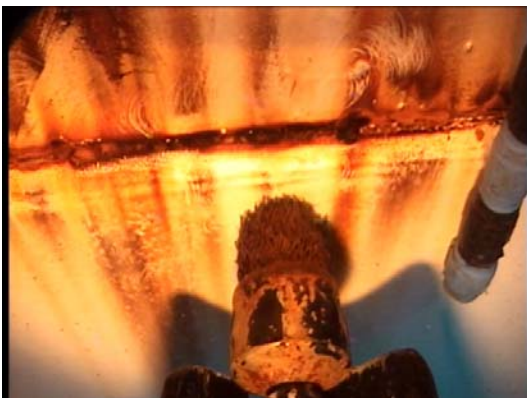
The interior coating is in good condition except for the first horizontal shell weld above the floor. Numerous corrosion cells were found on this weld with small pitting. It appears that the weld was never stripe coated during the coating application process.

VS # 6: Corrosion area on lower horizontal weld after wire brushing
(Time: 14:40)

The interior coating is in very good condition except for the first shell course. It appears that the metal loss is minimal and the coating should be adequate until the next inspection cycle.

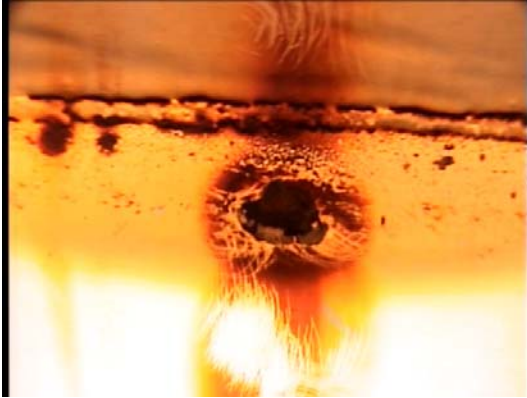
VS # 7: Small pit below horizontal weld seam (Time: 17:23)

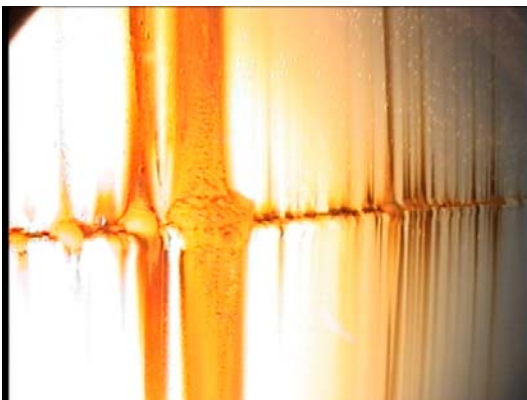
VS # 8: Numerous corrosion cells on horizontal weld seam (Time: 18:55)

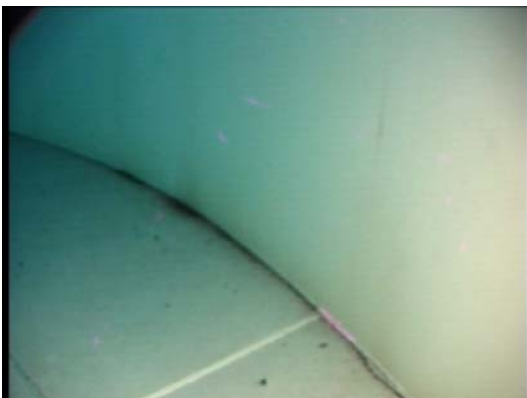
The floor had only minimal sediment layer with some rust particles built up around the perimeter due to the corrosion on the first shell weld see VS# 9. No corrosion cells were found on the shell plates.

VS # 9: Floor to shell seam in good condition (Time: 22:10)

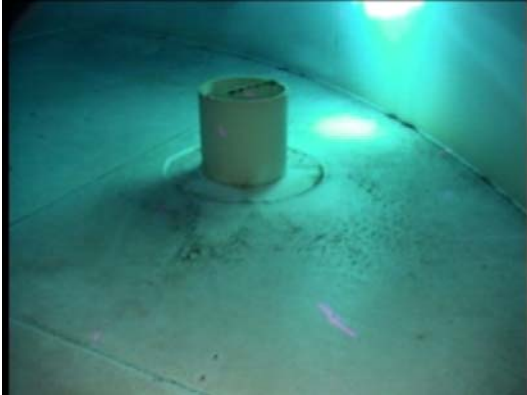
The tank has one combined inlet-outlet pipe see VS# 10. The pipe is equipped with a sediment ring that is in good condition.

VS # 10: Inlet/Outlet pipe with sediment ring (Time: 23:30)

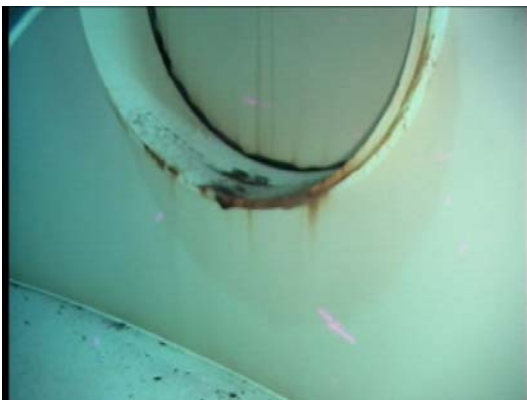
Minor edge corrosion was found on the shell manway neck see VS# 11. No problems were found with the sealing surface.

VS # 11: Minor edge corrosion on neck of shell man way (Time: 23:45)
