**Town of New Hartford - 175k GST  
Water Storage Tank Inspection**

**CorrTech Report No. 14845-FOR-01-1**

**1/26/2021**

### **Tank 2 174,000 Gallon Steel GST**

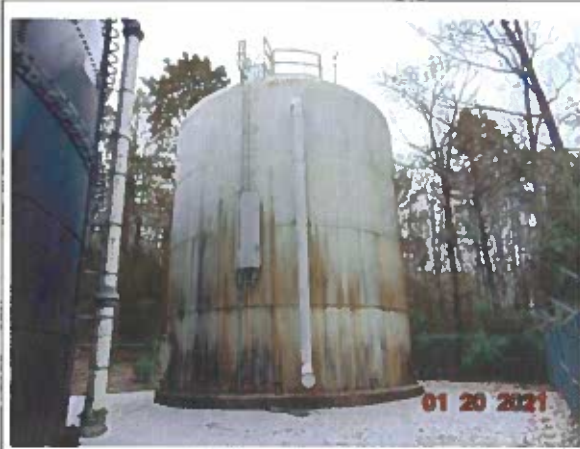
#1 Tank overview

The exterior coating has heavy biological staining with some minor areas of corrosion. No significant coating loss or adhesion loss was observed.

Exterior shell and roof surfaces should be cleaned using high pressure water to remove biofilm that is unsightly and may contribute to degradation of the coating system.

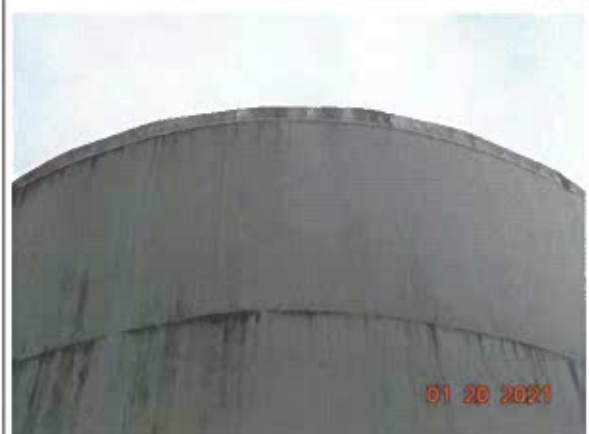
#6 Typical view of upper shell rings

The shell coating was mostly intact with 5% of weld seams covered in corrosion cells. Some cells were brushed and little to no coating remained.

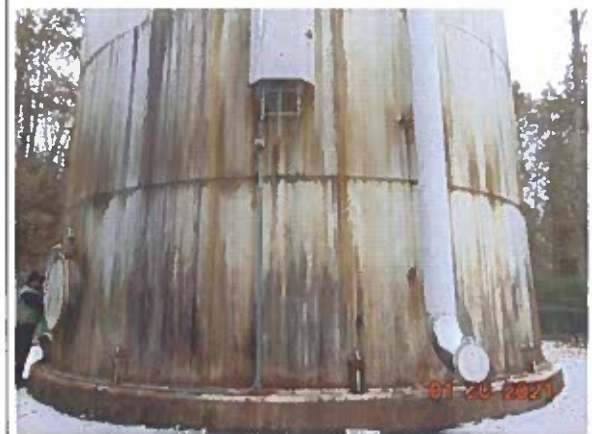
#12 Tank ladder height from grade

The ladder was intact. No deformations or corrosion was observed.

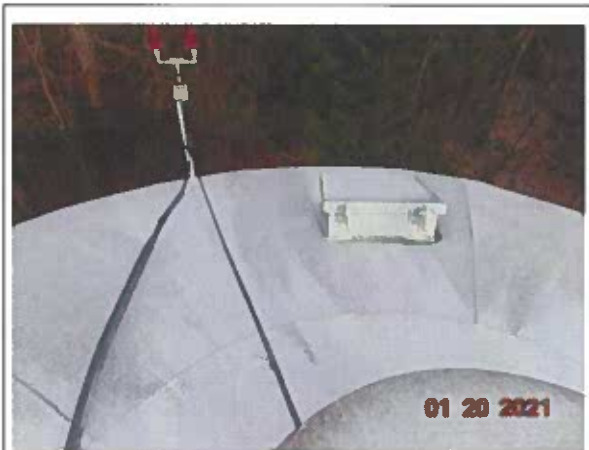
#16 Secondary roof hatch

The roof hatch showed no signs of any perforations and no signs of leakage were found. The hinges allowed the hatch to move freely.

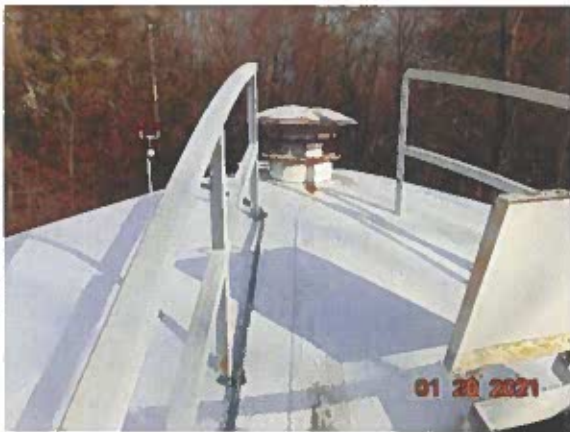
#14 Roof overview

The tank roof is a self-supporting dome structure. No deformations, bowing or buckling, or any metal loss was observed in any of the roof plates.

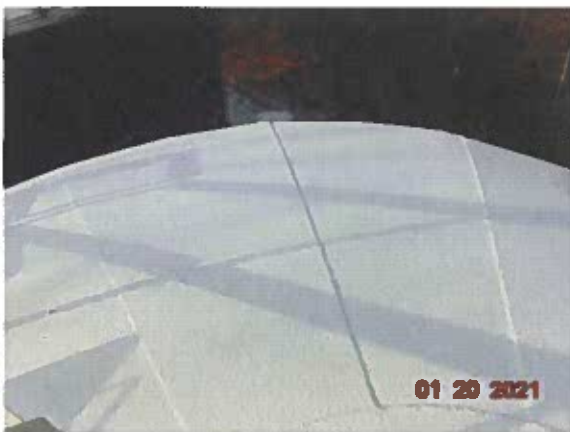
#15 Typical view of roof plates

The roof had 30% corrosion focused along weld seams. No large areas of delamination were noted.

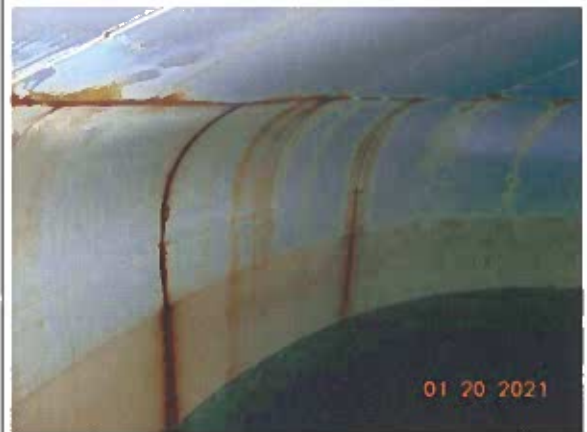
#23 Interior view of shell

Corrosion has formed on seams throughout the interior roof and shell of the tank. No significant coating loss or adhesion loss was observed.

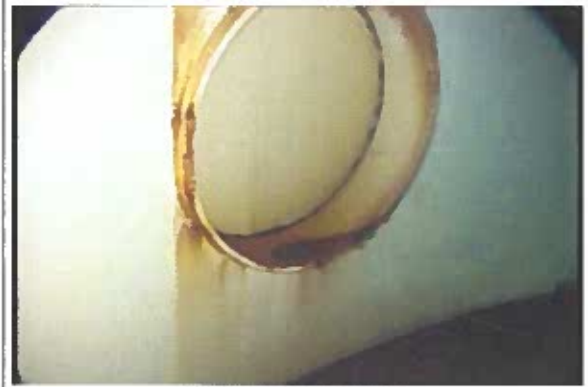
12:14 Sell manhole

The tank has two shell manholes. All bolts are engaged on both and no signs of any leakage were identified.
