WPCA

HAND OUTS - AMENDED

**Town of New Hartford - 175k GST
Water Storage Tank Inspection**

CorrTech Report No. 14845-FOR-01-1

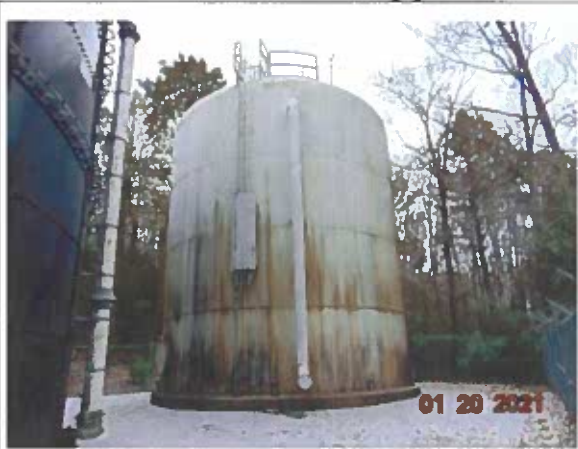
#1 Tank overview

The exterior coating has heavy biological staining with some minor areas of corrosion. No significant coating loss or adhesion loss was observed.

Exterior shell and roof surfaces should be cleaned using high pressure water to remove biofilm that is unsightly and may contribute to degradation of the coating system.

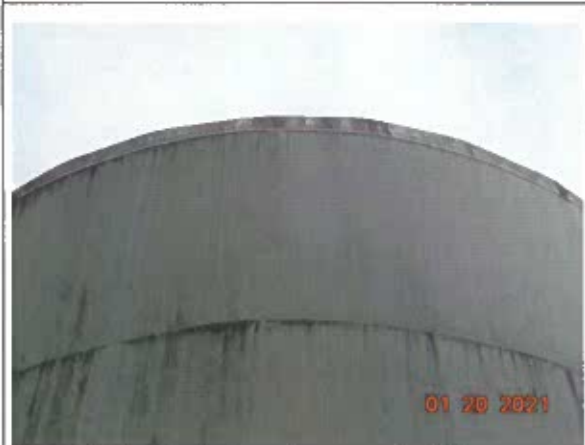
#6 Typical view of upper shell rings

The shell coating was mostly intact with 5% of weld seams covered in corrosion cells. Some cells were brushed and little to no coating remained.

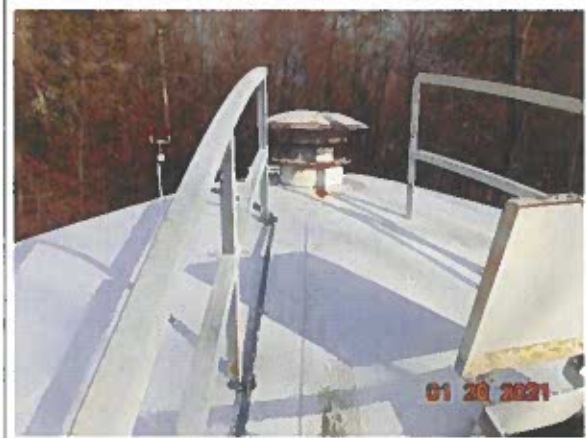
#14 Roof overview

The tank roof is a self-supporting dome structure. No deformations, bowing or buckling, or any metal loss was observed in any of the roof plates.

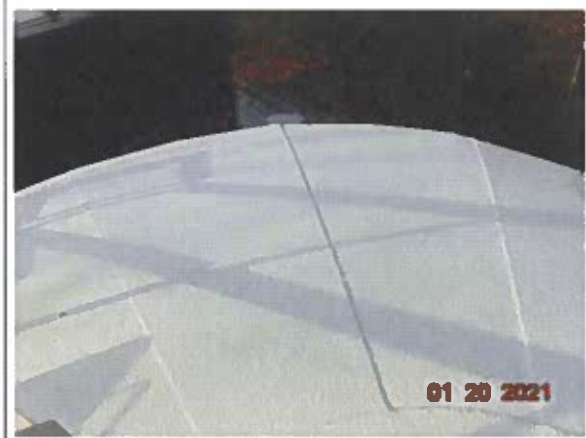
#15 Typical view of roof plates

The roof had 30% corrosion focused along weld seams. No large areas of delamination were noted.

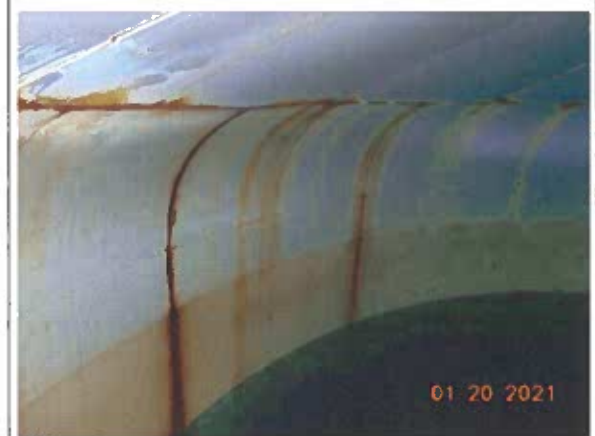
#23 Interior view of shell

Corrosion has formed on seams throughout the interior roof and shell of the tank. No significant coating loss or adhesion loss was observed.

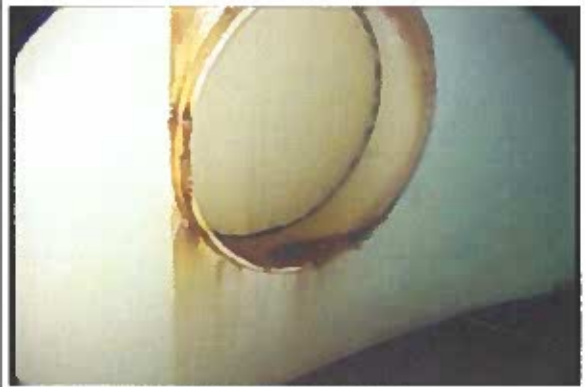
12:14 Sell manhole

The tank has two shell manholes. All bolts are engaged on both and no signs of any leakage were identified.
