Subject: Aquastore Tank Inspection Report
New Hartford, CT
Model 5033 MIP 8900015

New Hartford, CT
Aquastore Water Storage Tank Inspection
Dry Inspection – 4/15/15
Model 5033; 491,000 Gallons; MIP - 8900015

On 4/15/15, Statewide Aquastore, Inc conducted an interior and exterior inspection of the 491,000 gallon Aquastore® water storage tank noted above. This inspection is to provide information regarding the overall condition of the tank. The tank has been in service for approximately 25 years. It was installed and put in service in 1990.

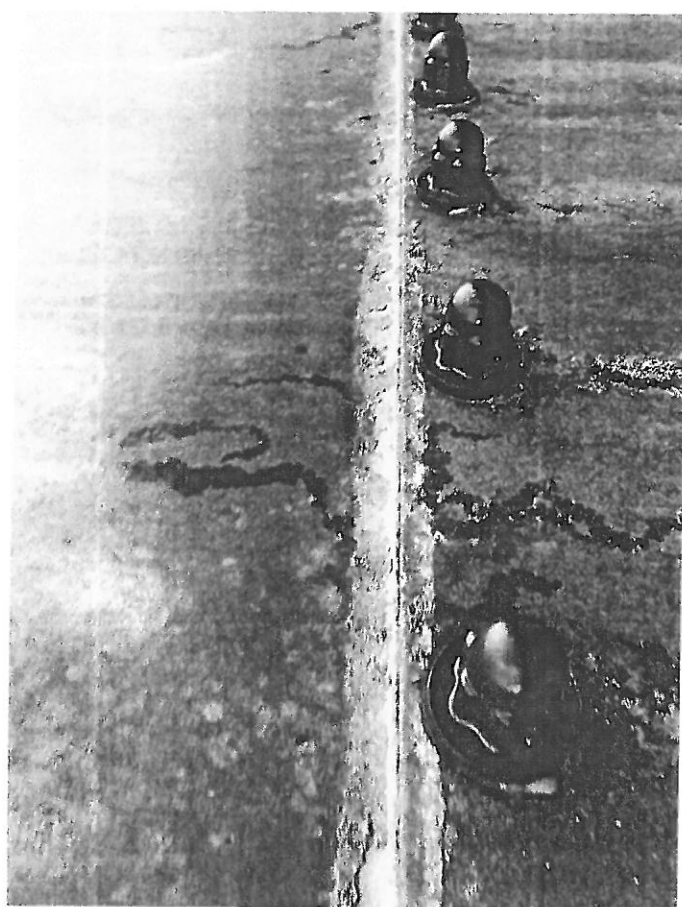
Exterior Horizontal Seam

Other Comments: The exterior sheet edges are exposed and are beginning to corrode. The edges should be resealed. By installing a new sealer fillet, you are providing a layer of protection against the elements and enhancing both the aesthetics and longevity of the tank.

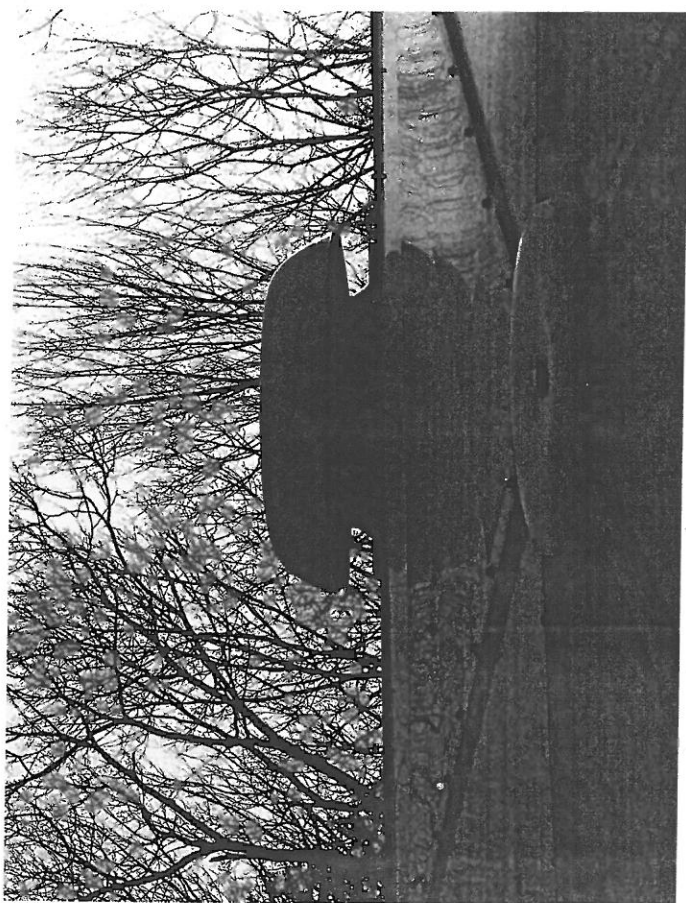
Gravity Vent

- The roof vent is clean and clear with all screens in place.
- The roof manway is in good condition.
- A SWA or water department padlock is missing from the roof manway and should be replaced.

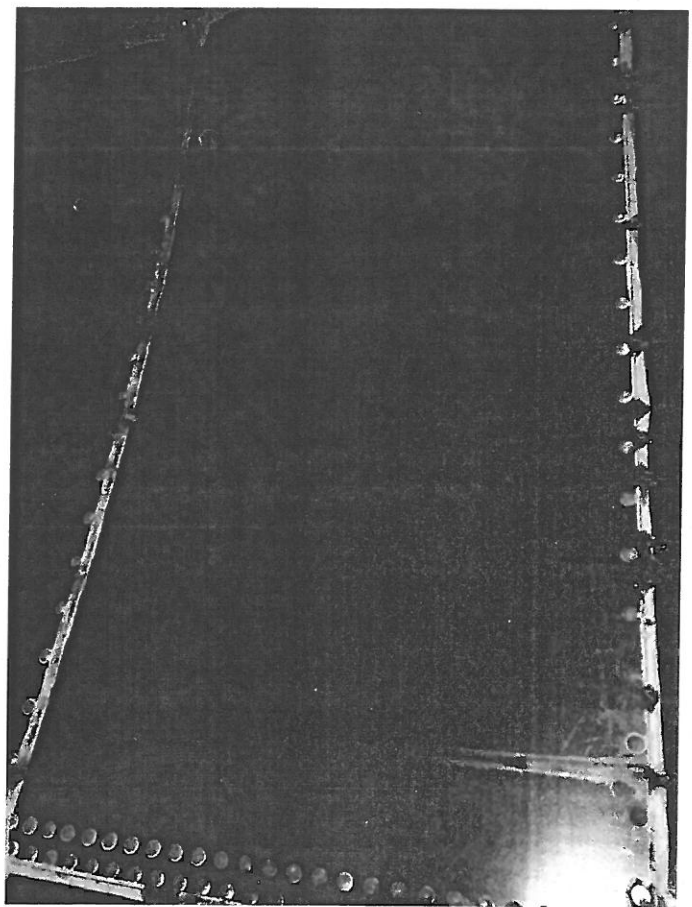
Interior Sheet

- The sealer has deteriorated and has exposed some of the sheet edges. There is some corrosion present.

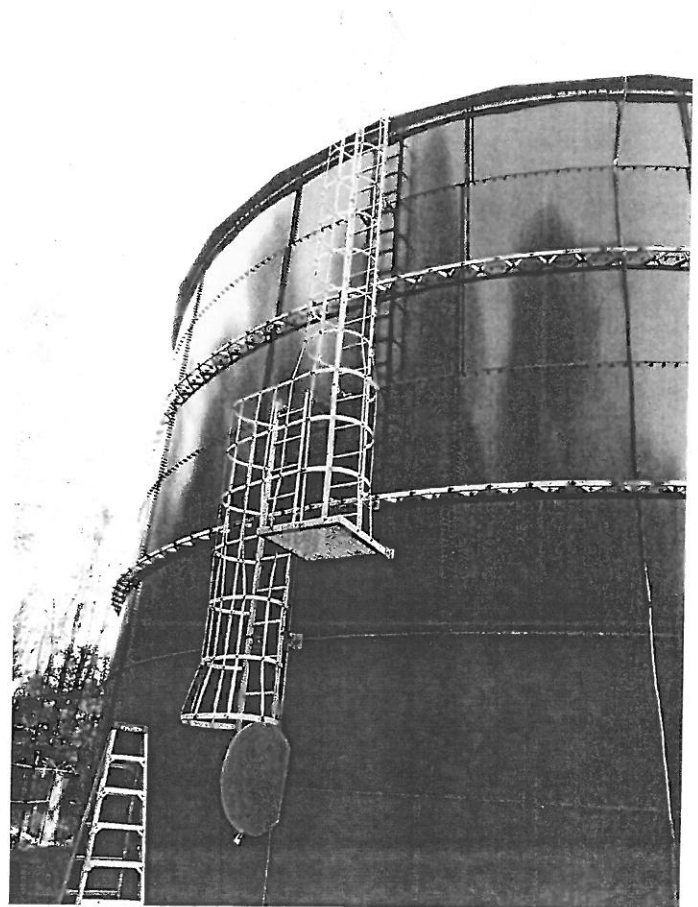
Ladder System

- The entire ladder, step off platform, safety cage, etc. is in good condition and securely bolted to the tank.
- A ladder blocking device is present and secured with a Water Department padlock.
- The ladder starts at the top of the first ring.

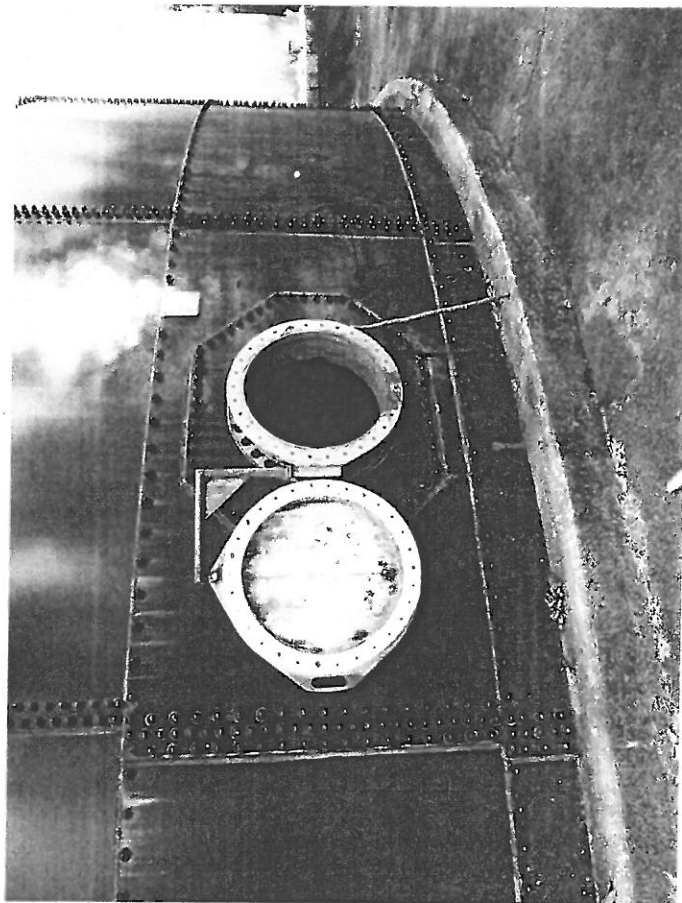
Manway 1

- The tank was constructed with (1) 24" bottom manway.
- The manway is in good condition with all fasteners in place and no signs of leakage present.
- The manway davit arm is secure and in good condition.
- The reinforcing plate is in good condition.

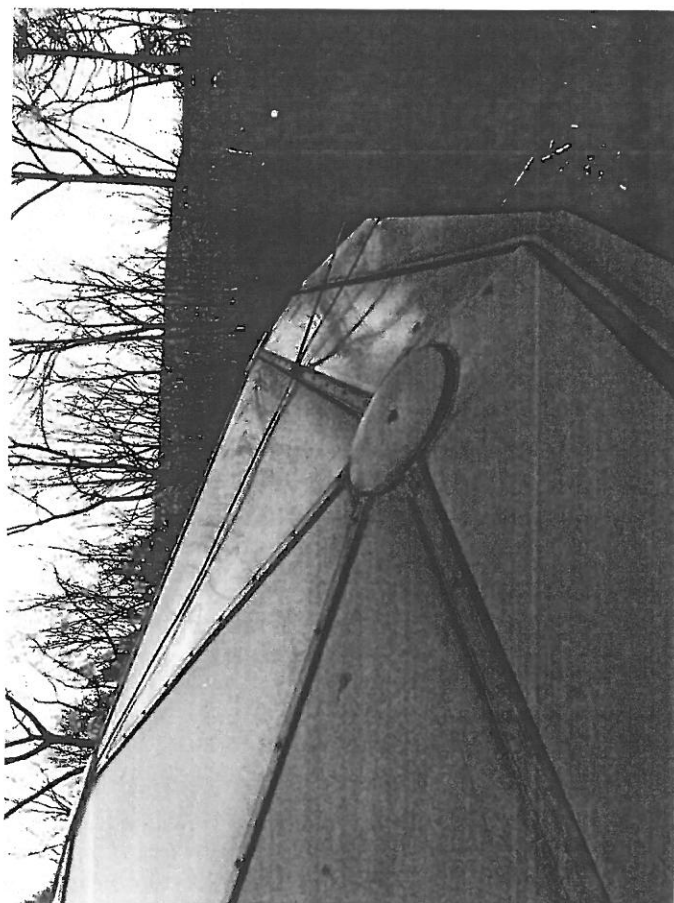
Roof Flashing and Gussets

- The entire roof and appurtenances were inspected and overall are in good condition.
- The battens and dome panels are in good condition.

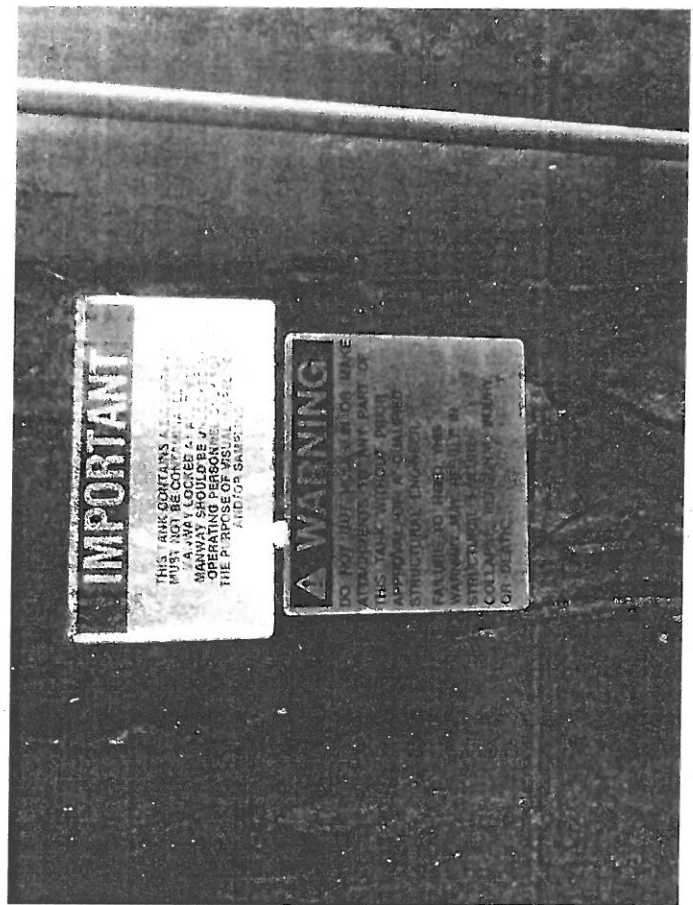
Safety Decal

- No signs of vandalism are present.
- All safety decals and nametags are in their proper places and are in fair condition.
